Lower Dolores River
2017 McPhee Reservoir
Managed Release
Ecological Monitoring & Evaluation

Volume 1: Summary
February 2018

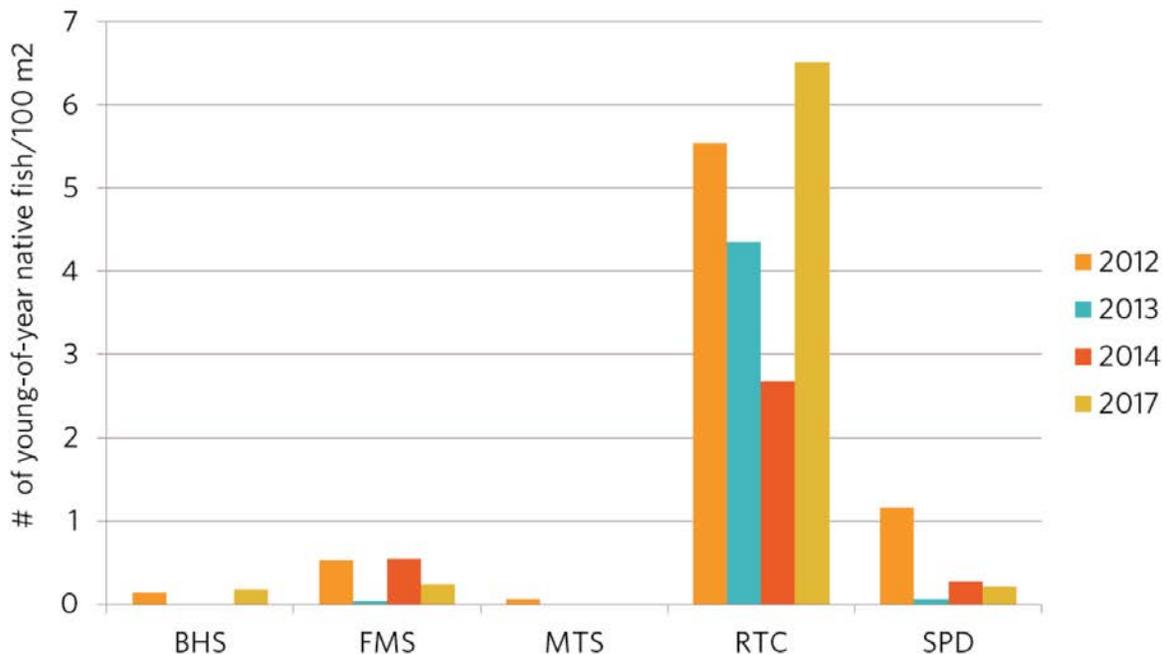
Figure 1. Young-of-year native fish by species caught in reproduction surveys on the Dolores River in 2012 (orange), 2013 (blue), 2014 (red), and 2017 (yellow). CPUE = Catch per unit effort, BHS = bluehead sucker, FMS = flannelmouth sucker, MTS = mottled sculpin, RTC = roundtail chub, and SPD = speckled dace. Reproduction of all three species of sensitive native fish occurred in 2017. Young-of-year flannelmouth suckers and roundtail chubs have been detected in every survey year. Bluehead sucker reproduced in 2017 and 2012, but were not detected in 2013 and 2014.

- Roundtail chub reproduction was evident at most sites, including the Dove Creek Pumps reach, James Ranch Reach, and Big Gypsum Reach. Young-of-the-year bluehead and flannelmouth suckers were also detected, but at low levels. Findings about 2017 reproduction are preliminary because detection of young-of-year fish is difficult; population surveys in future years will provide a better indication of how much reproduction of native species occurred this year.

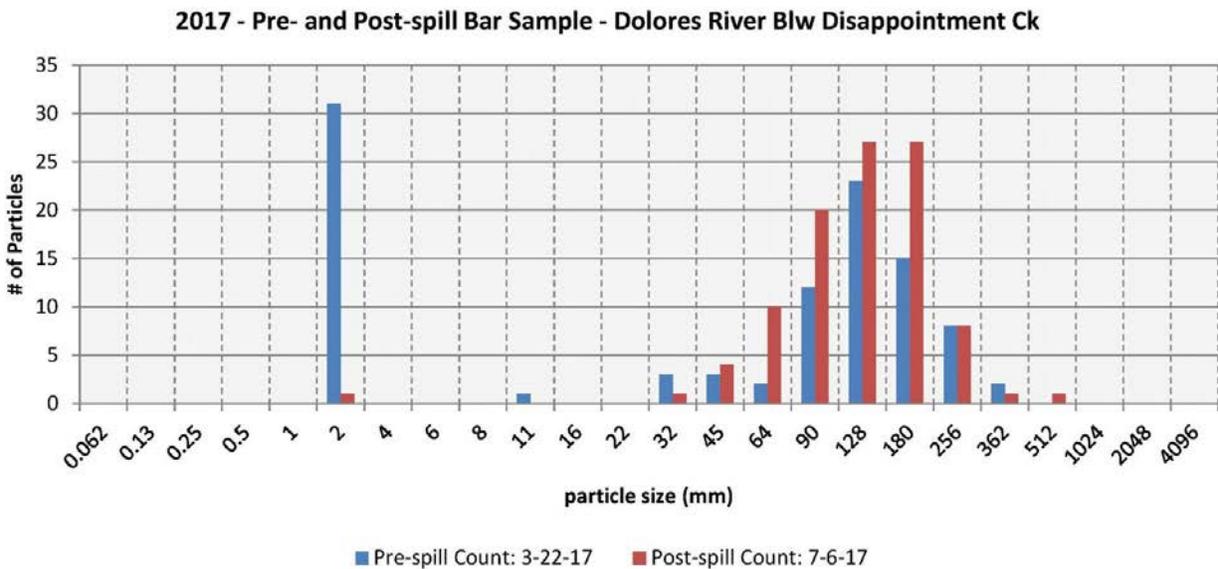
Figure 2. Slickrock Downstream (Below Disappointment Creek) site Wolman pebble count results 2017. These important results show that 2 mm particles were almost completely removed from the site.

- At the Slickrock Downstream site, fine sediments (2 mm particles) were almost completely removed from the survey area with the 2017 managed release (Figure 2 below). Though the measurable benchmark associated with fine sediment removal is in reference to in-channel riffle habitats, this result is important because it indicates that higher-energy sites within the active channel were at least equally coarsened by the managed release, which improves breeding and foraging habitat for native fish.

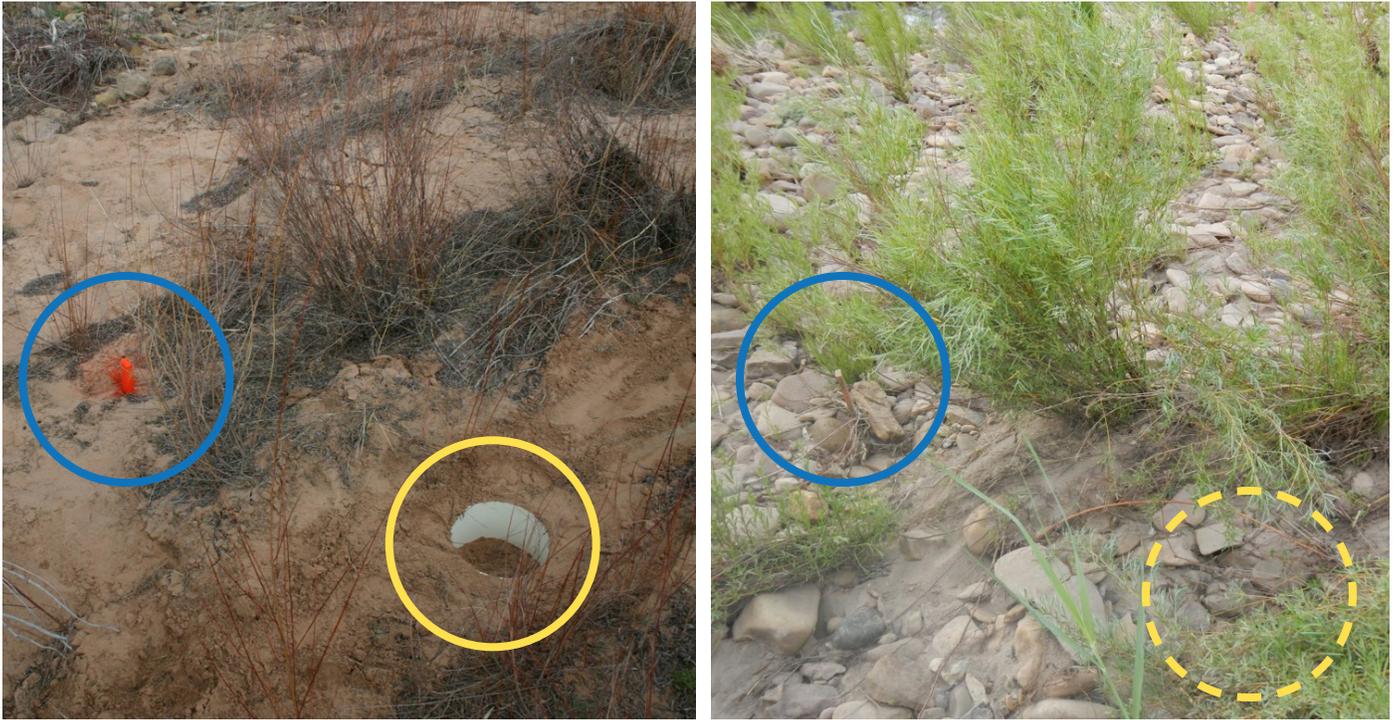
Figure 3. Slickrock Downstream sediment trap (yellow circle) and erosion stake (blue circle); pre-release photo on left (3/22/17), and post-release photo on right (7/6/17). Note the scouring of fine material observed with the orange erosion stake between pre- and post-release. It is estimated that the sediment trap was washed away with strong scouring flows during the managed release (absence of sediment trap post-release).

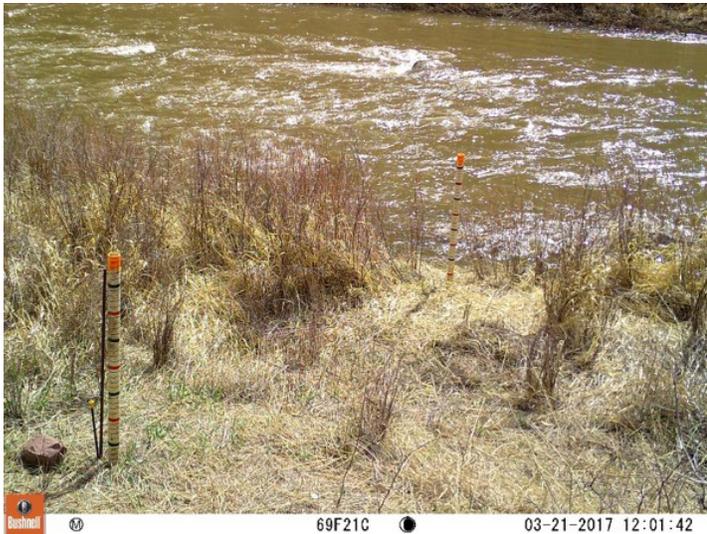
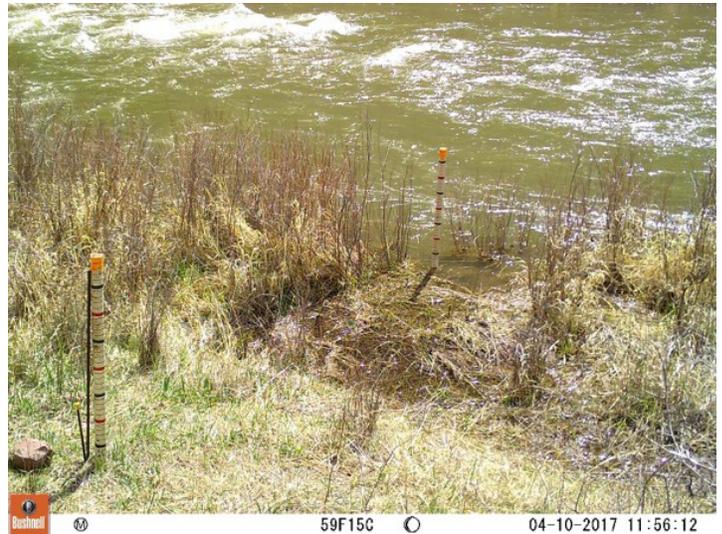
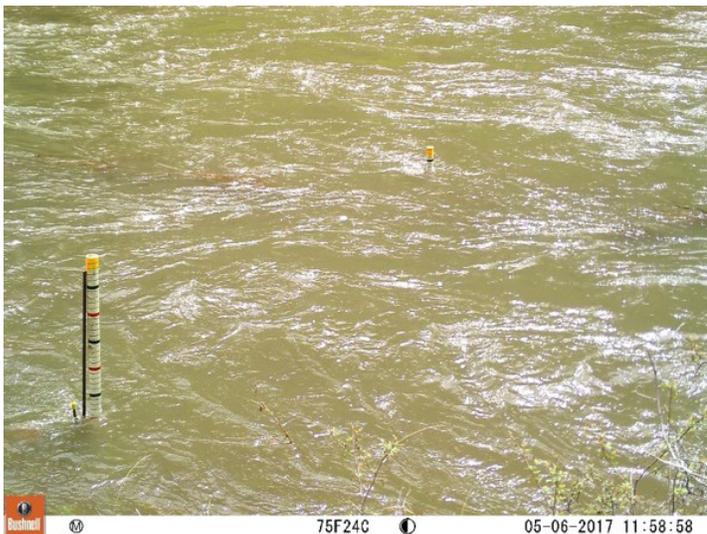
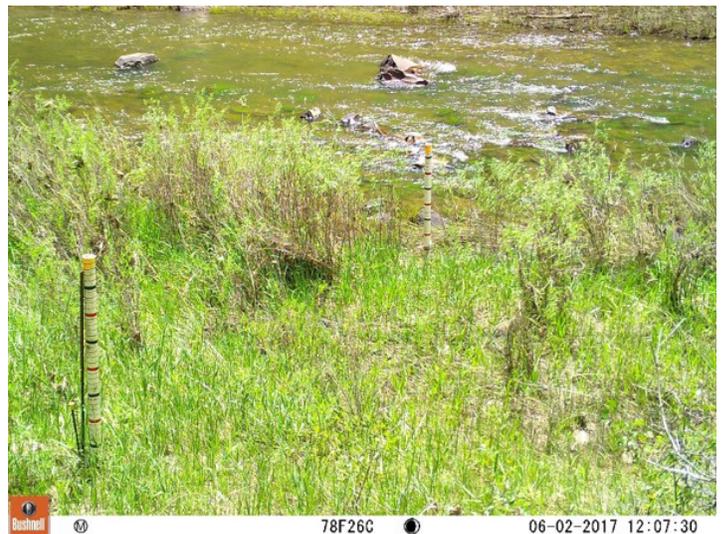
Figure 4. Dove Creek staff gage at pre-release, rising water, peak-release, and post-release. Notice river rising substantially out of its banks at peak-release but with very little change in the amount of woody vegetation.

- Cameras captured the river rising substantially out of its banks at multiple sites during peak-release, an important benefit of the managed release, resulting in noticeable sediment deposition and scour, and crucial recharging of the alluvial aquifer (see Figure 4 below).
- Images do, however, also show minimal bank erosion, providing further evidence of the substantial ‘armoring’ of the banks at multiple sites.

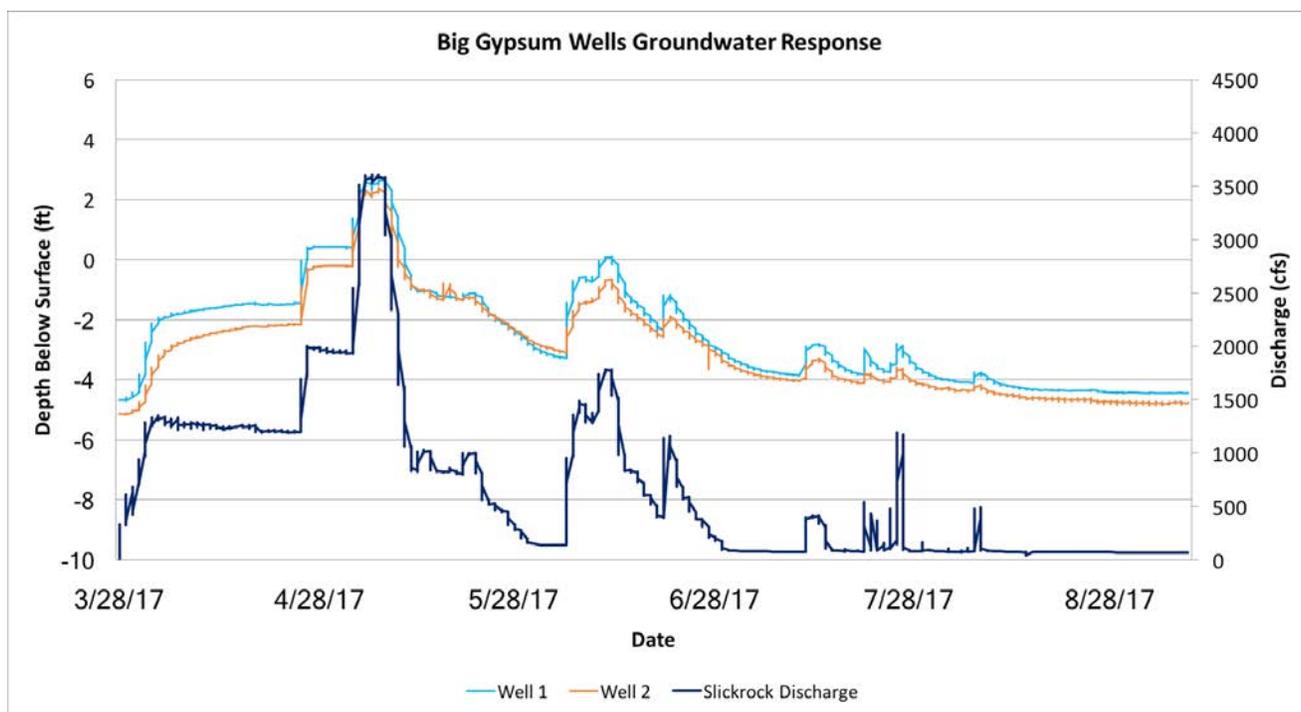
Figure 5. Big Gypsum site in 2017, showing Slickrock Discharge and groundwater well data for a high-flow release. Note that both Well #1 and Well #2 show groundwater depths of 2 feet or less from the beginning of April through the end of July.

- High flows and a long-duration release improved water table levels at both sites, with the biggest improvement at Big Gypsum, resulting in groundwater depths of 2 feet or less from the beginning of April through the end of July, providing much needed water for pre-existing adult cottonwoods (Figure 5 below).

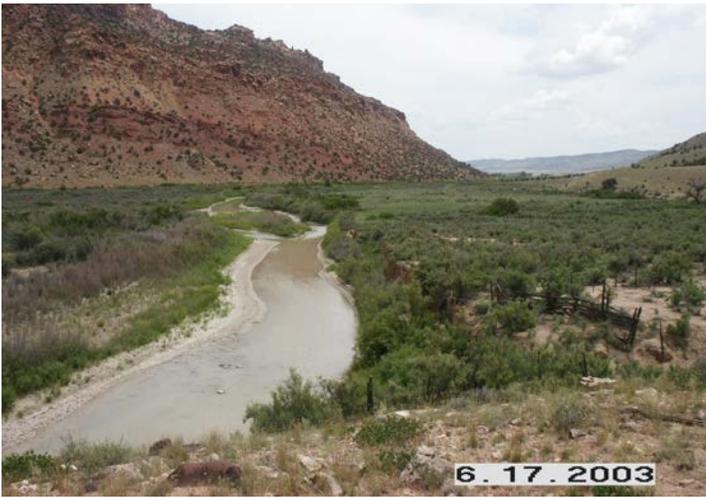
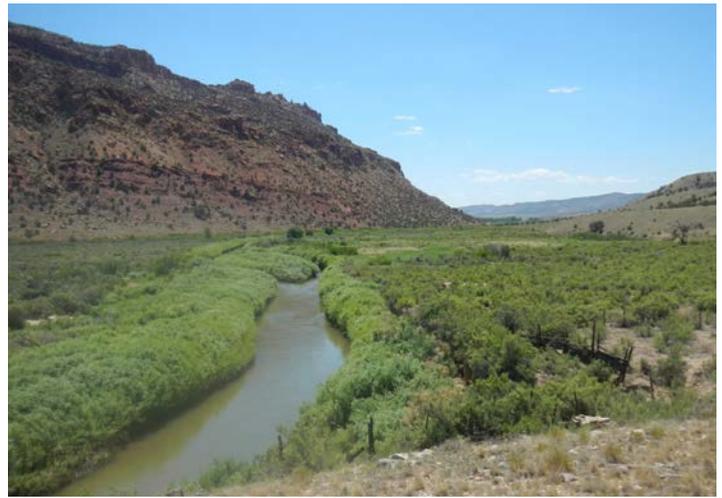
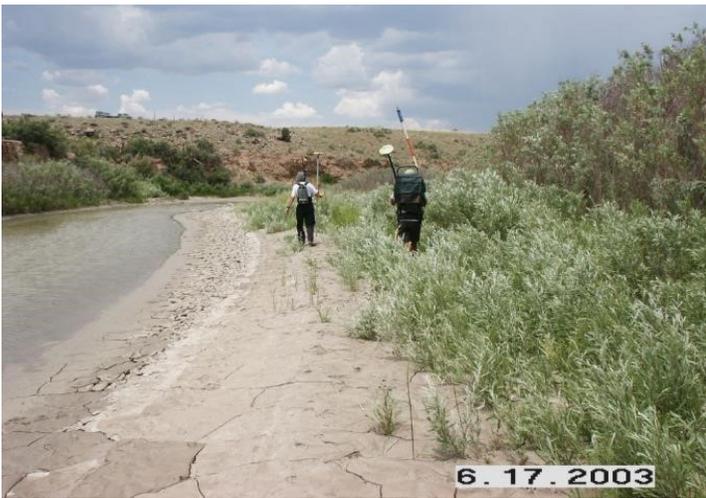
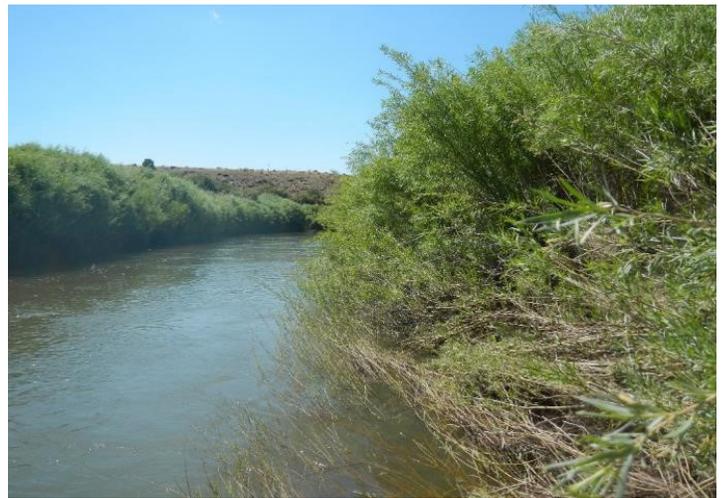
Figure 6 (a-d). Historic Big Gypsum Photo Point #2 (top photos) and Photo Point #6 (bottom photos) taken in 2003 (6/17/03) (photos on left) and 2017 (6/26/17) (photos on right). The photos show how, between these years, riparian vegetation increased in size, cover and density, and bare ground between plants decreased.

- Comparison of historic repeat photos confirm noticeable willow encroachment on point bars and river banks from 2003 to 2017, and appear to also have increased in density from 2003 to 2017 along the river bank at the Big Gypsum site (See Figure 6 below).

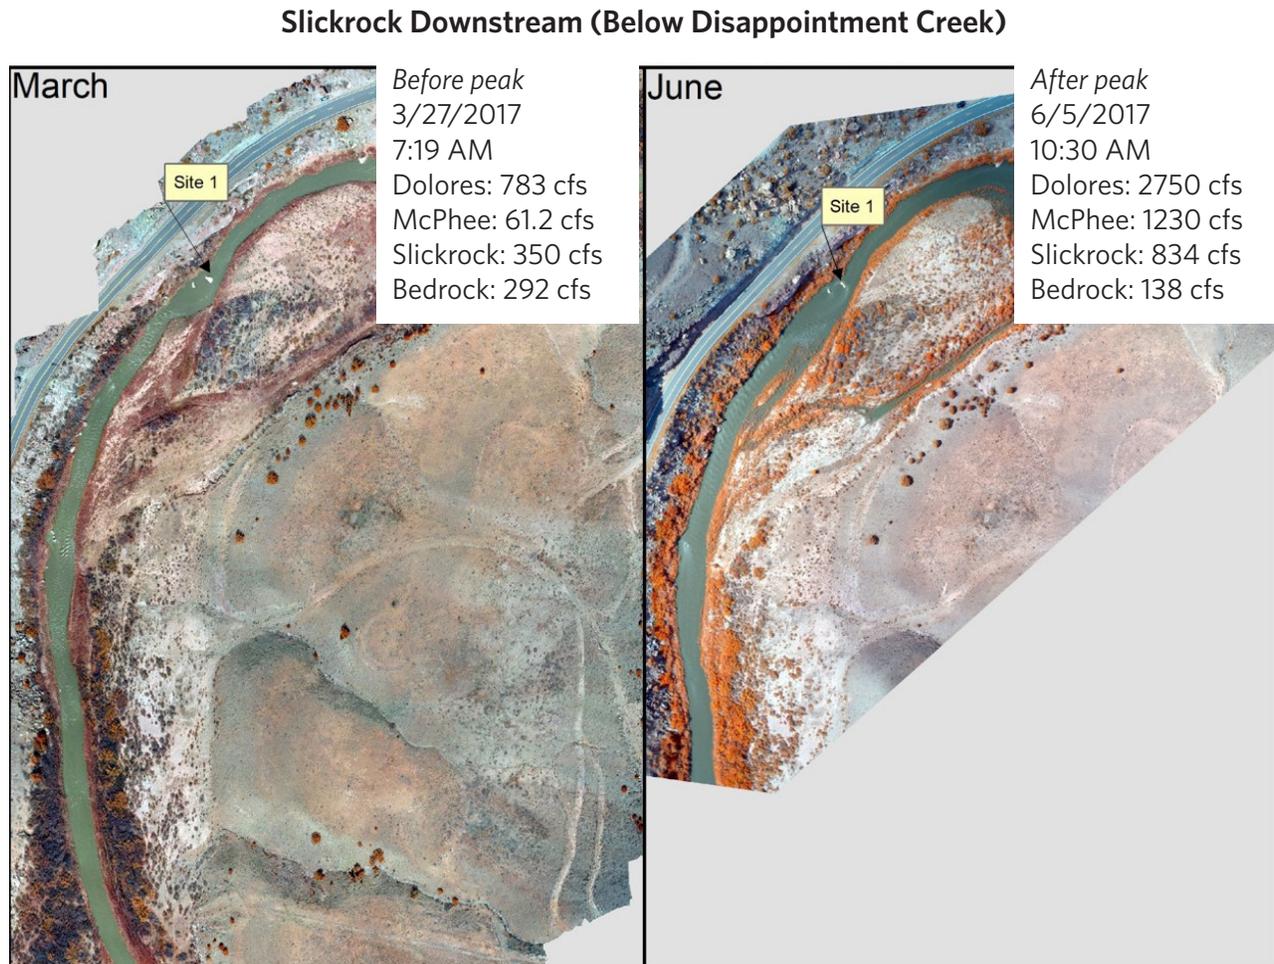
Figure 7. Drone imagery comparison March versus June 2017 at the Slickrock Downstream site. There is very little difference in planform pre- versus post-release. Most of the differences observed is because of higher water levels in June photos. Higher flow caused side-channel flow here, and floodplains stand out as a whiter color because of sand deposits.

- Pre- versus post-release drone imagery in 2017 revealed virtually no change in river planform (See Figure 7).
