Evaluating Potential Barriers to Cottonwood Regeneration in the Big Gypsum Study Area: Dolores River, CO

By Rob Anderson
June 30, 2010

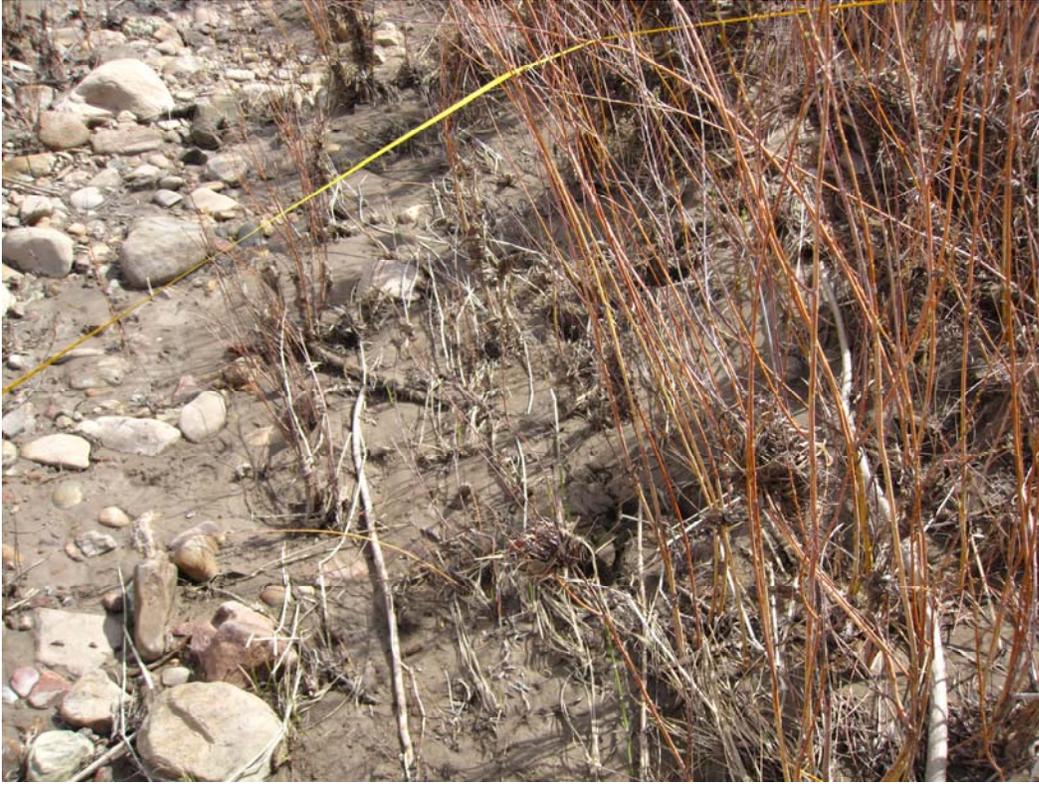
Photo #1: Transect #3 Near the River's Edge Dominated by Coyote Willow.

Throughout the transect, the average percentage of bare soil observed was 56.7 % and ranged from 10 to 100%. Photo #1 portrays the amount of bare soil adjacent to the channel. The presence of bare soil suggests that the potential of spring floods to create bare soil is not a barrier to cottonwood regeneration in this transect.

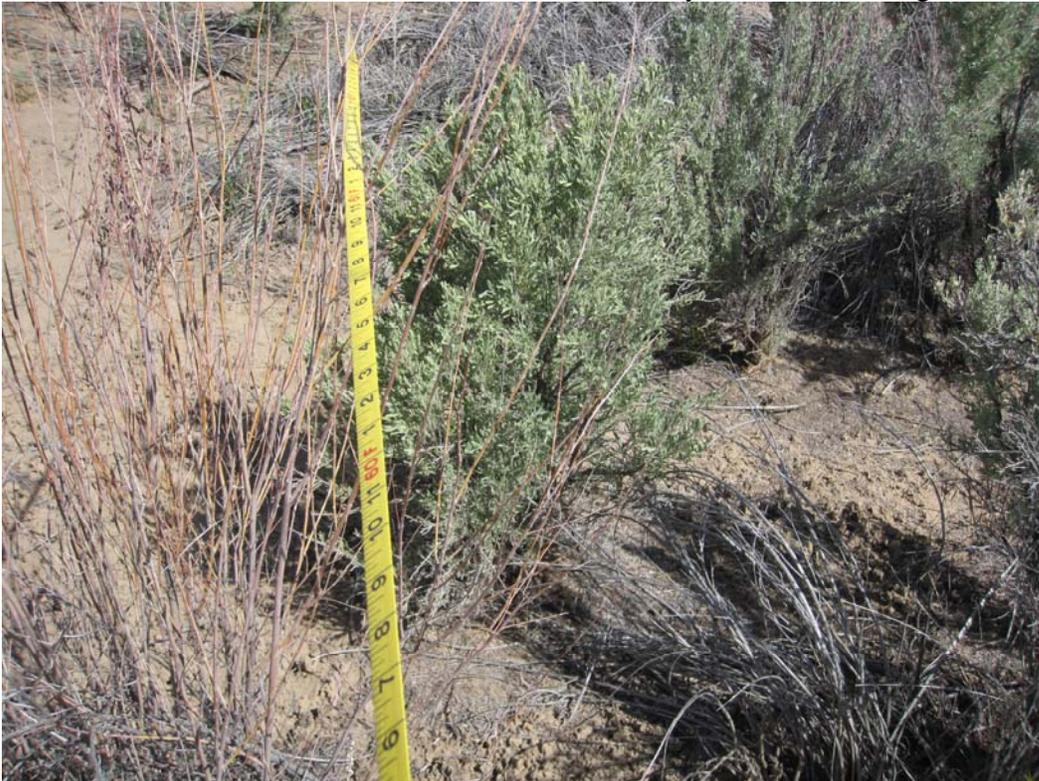
Photo #2: Transect #3 in the Transition Area from Coyote Willow to Sage.

The vegetation in this 200-foot transect (oriented perpendicular to the channel) transitions from a riparian area dominated by coyote willow (*Salix exigua*) near the river to upland vegetation dominated by basin big sage (*Artemisia tridentata*). Coyote willow is the dominant woody species from 0 to 50 feet from the river's edge (photo #1), while small numbers of tamarisk, New Mexico wild privet (*Foresteira pubescens*), and cottonwood are also present. From 50 to 100 feet from the river's edge, the vegetation transitions from a coyote willow-dominated community, into an upland area dominated by big basin sage (Photo #2). In this area, there are a few individuals of privet, rabbitbrush (*Chrysothamnus nauseosus*), and many dead coyote willow carcasses (photo #3). From 100 to 200 feet from the river's edge, the vegetation is predominantly big basin sage (photo #3). In this area, there are a few individuals of rabbitbrush and dead coyote willow carcasses.

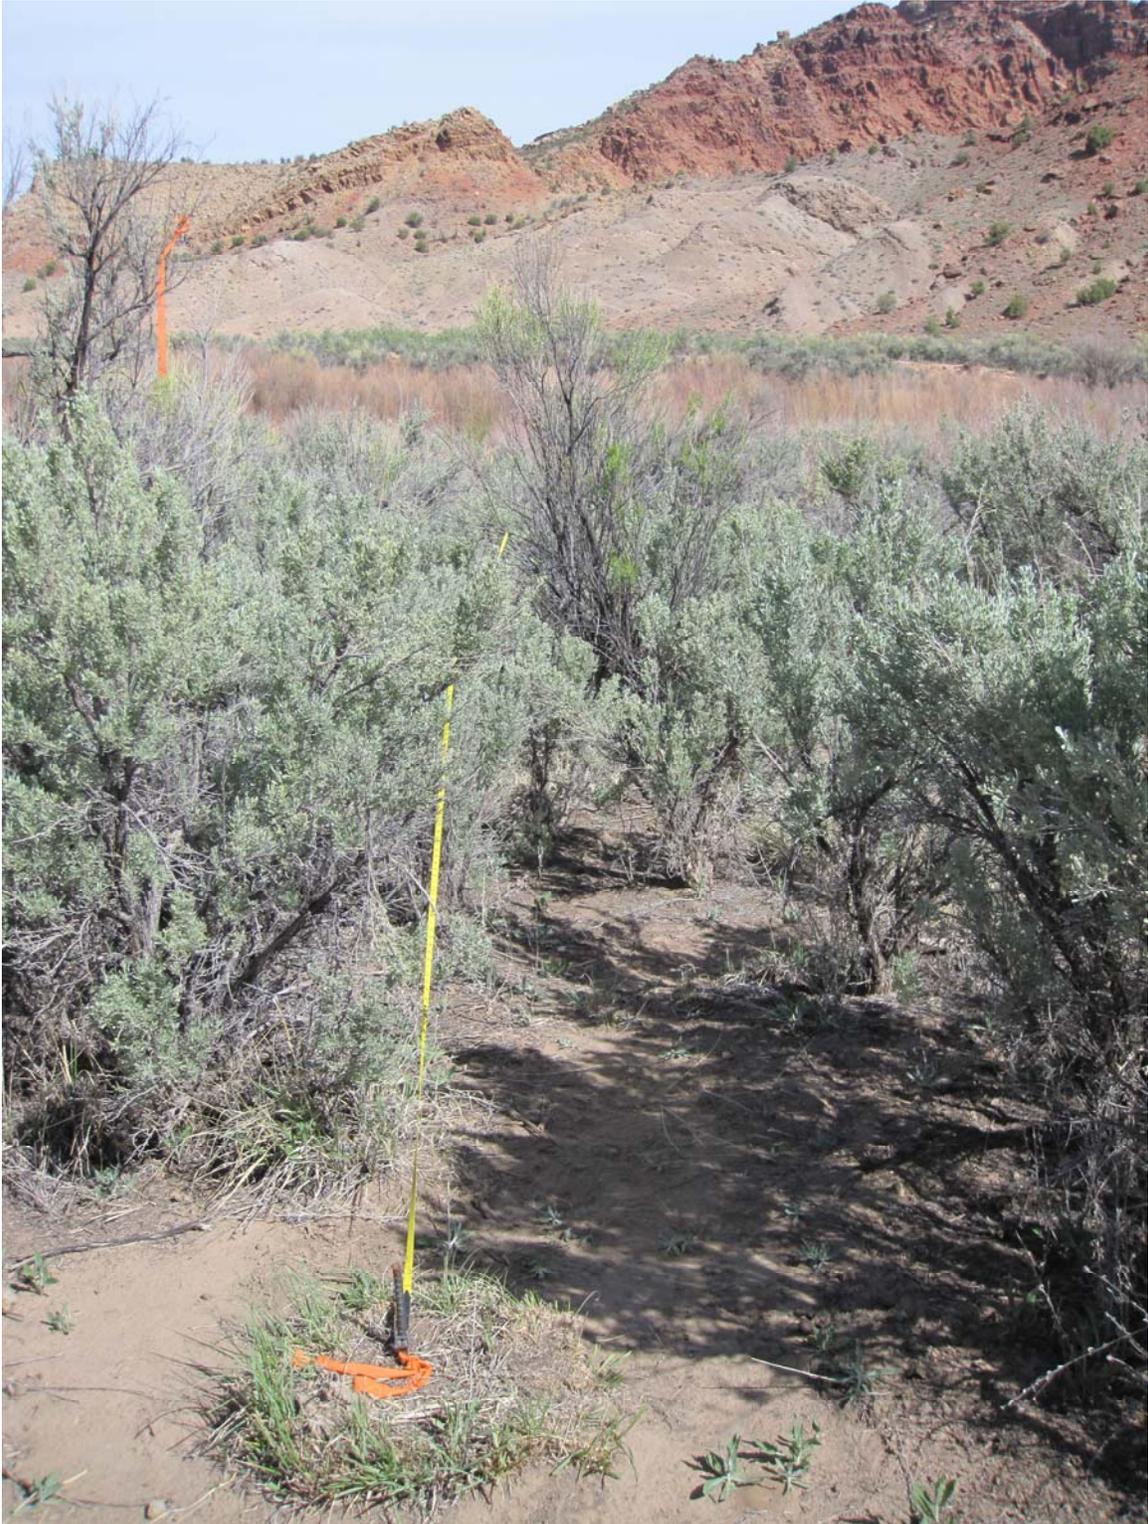
Photo #3: Transect #3 in the Area Dominated by Big Basin Sage

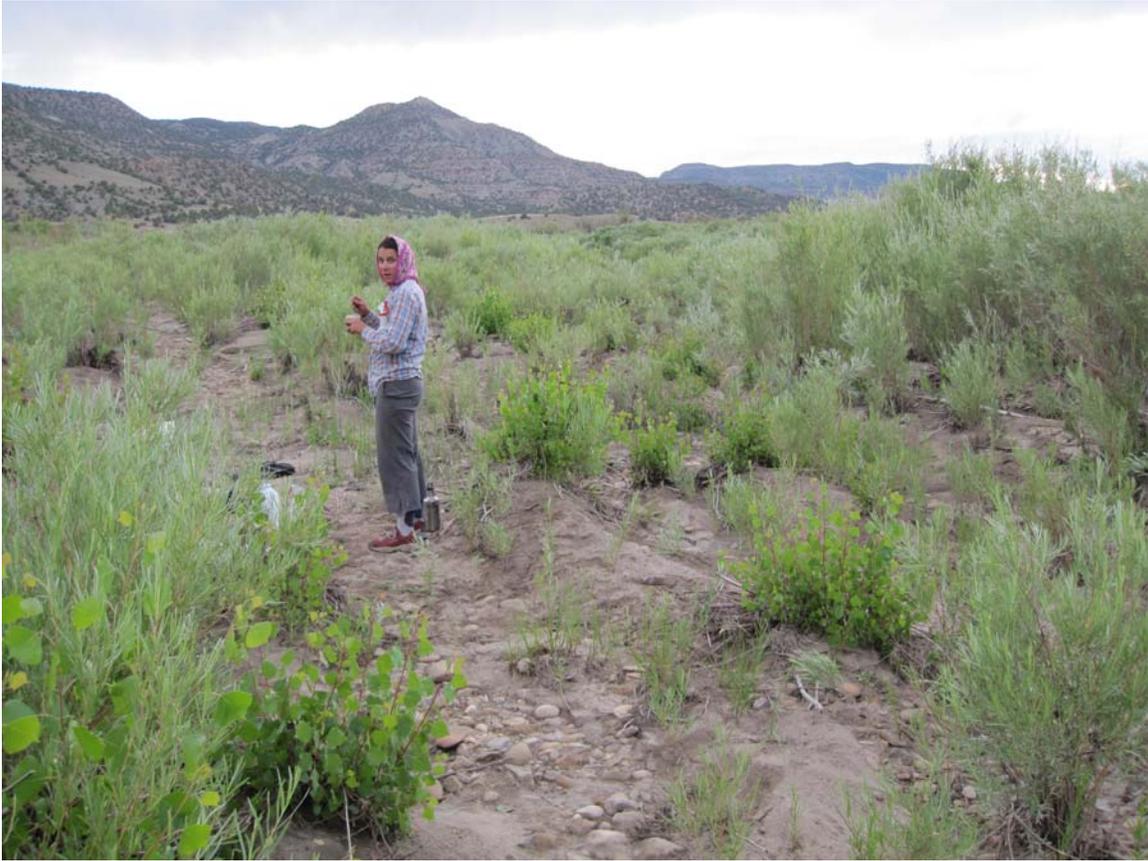
Photo #4: Transect #3, Beaver Damaged Cottonwood Trees

All of the mature cottonwood trees in this transect showed signs of beaver damage (photo #4). These trees stand about 2 feet tall and have several trunks, with 1-2 inch diameters, that have been severed by beavers. It appears that beaver damage in this

transect is a barrier to cottonwood growth. There were no new cottonwood seedlings along the entire transect.
