Lower Dolores River
2017 McPhee Reservoir
Managed Release
Ecological Monitoring & Evaluation
Volume 2: Detailed Methods and Findings
February 2018

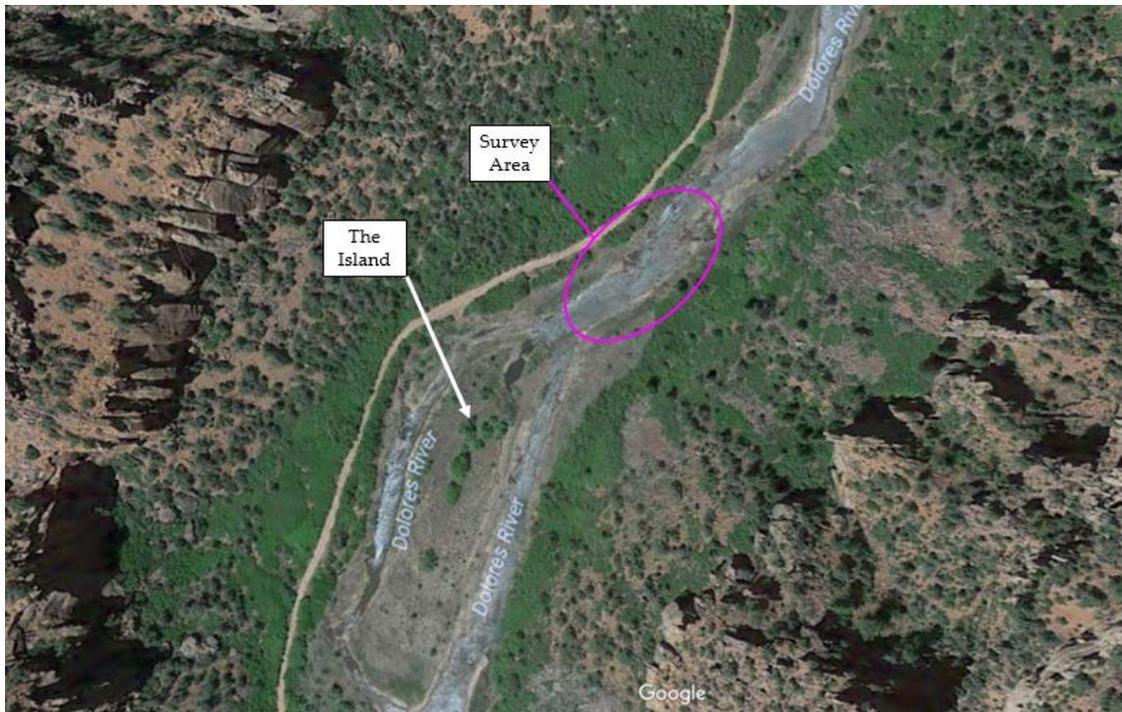
Figure 14. Dove Creek Pumps site overview, showing the location of the survey area circled in purple.

The Dove Creek Pumps site (Figure 14) is a confined, colluvial U-shaped valley type, with relatively stable, moderate side slopes, and a moderate valley slope. Located within a portion of the Dolores with steep canyon walls and a very narrow riparian corridor, there is a relatively low sediment supply, but areas of high sediment supply can occur. There is also large, woody debris here.

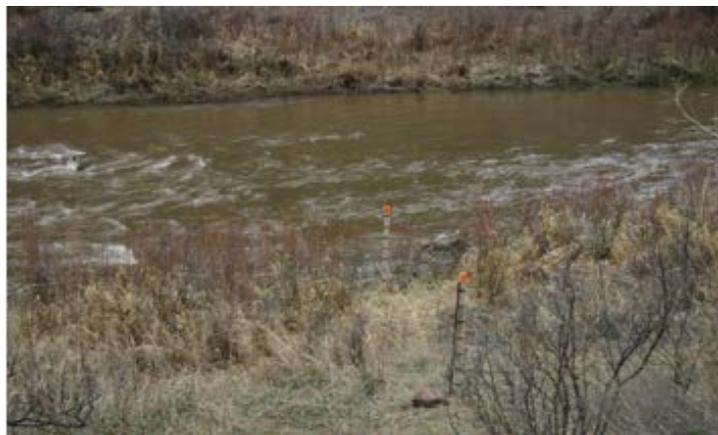
Figure 15. Dove Creek Pumps Site, upstream riffle cross-section. This is a pre-release photo of the riffle (March 2017).

Riffle (Figure 15) and pool cross-sections were conducted at this site. This was the only site that a riffle cross-section could be completed - monitoring of riffle habitat was planned for 2017 at all ecological monitoring sites but higher than anticipated flows in March prevented most of the riffle monitoring.

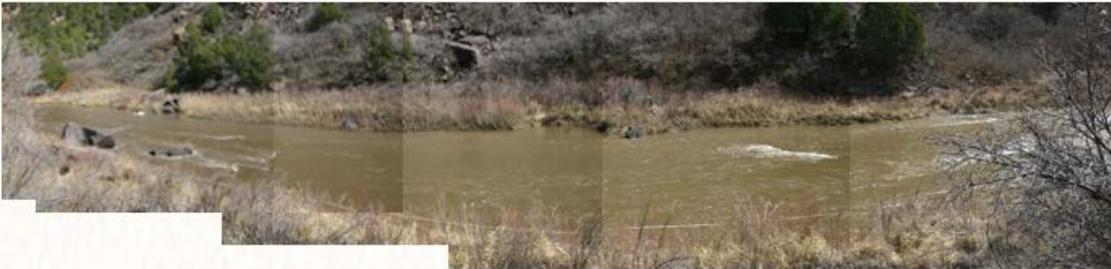
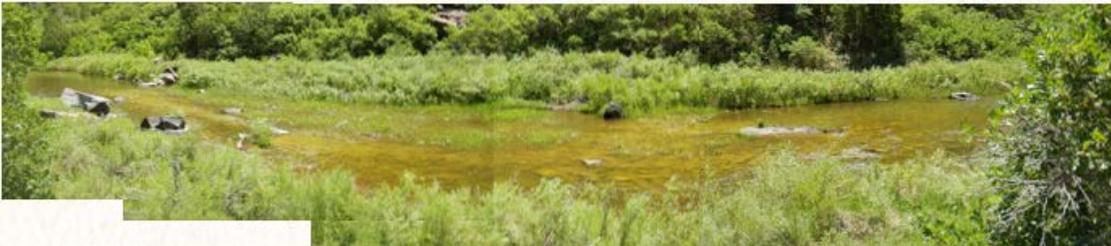
Downstream Pool Cross-Section

Pre-Release 3/20/17 #5248-5255

Post-Release 7/8/17 #1677-1685

Figure 18. Dove Creek Pumps Site, pool cross-section, shown for 2017 pre-release (March 20) and post-release (July 8).

Pre- and post-release 2017 cross-section comparisons for the riffle at this site show little change (Figure 16); the Dove Creek Pumps site almost represents a control reach, as it is a very stable, narrow riparian corridor. There was also not much change observed in the cross-sections when compared to 2004 (Figure 17). The pool cross-section also showed little change (Figures 18 and 19)

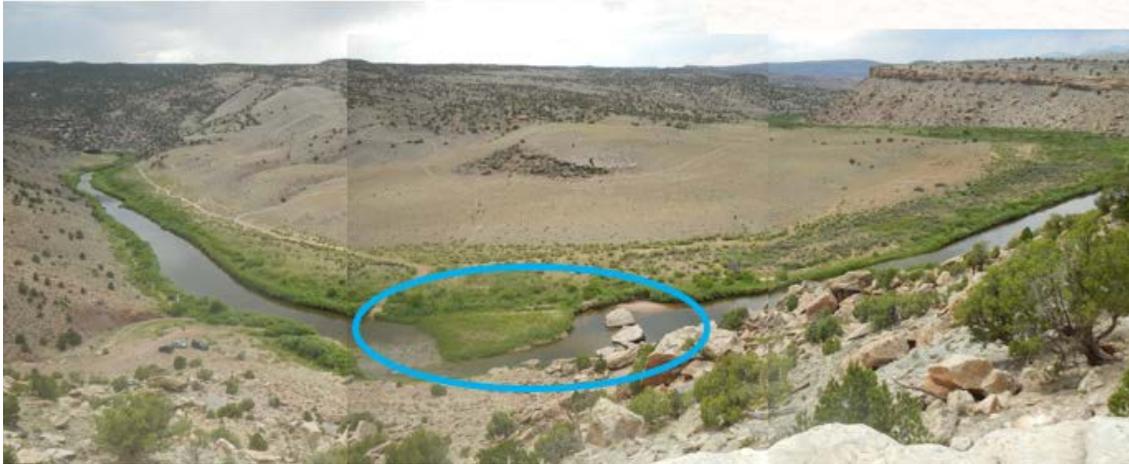
Figure 20. Slickrock Upstream Site Overview. Circle in blue shows the survey area. This is a post-release photo (8/6/17).

The Slickrock Upstream site is a semi-confined, alluvial valley type, with alluvial deposition and a narrow floodplain. It has a meandering riffle-pool system, with streambank erosional processes and a productive riparian community; there is not a lot of sinuosity in the stream (Figures 20-22).

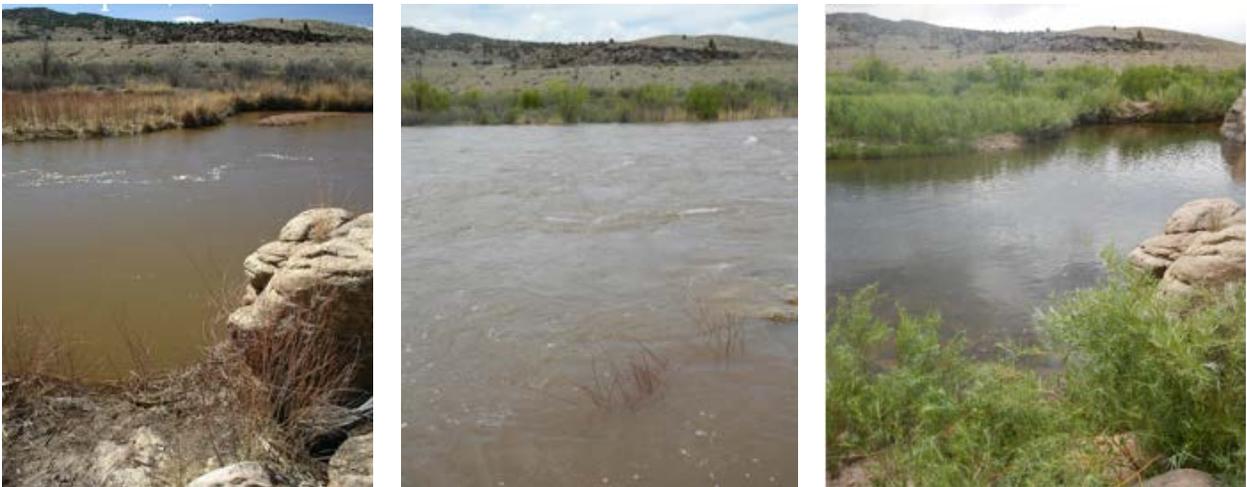
Figure 21. Slickrock Upstream Site, downstream pool. Photos of the pool are, from left to right, pre-release (3/24/17), peak-release (5/6/17), and post-release (7/6/17).

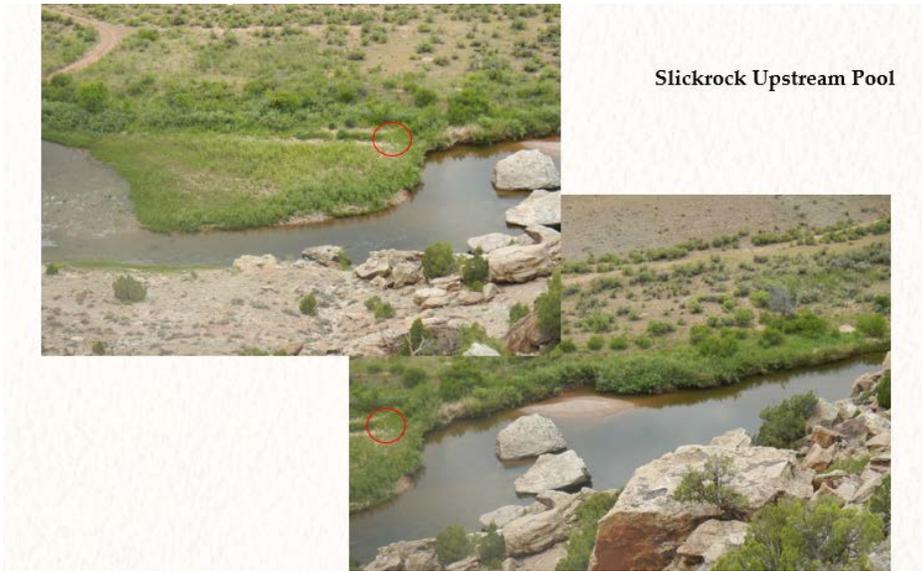
Slickrock Upstream Pool

Figure 22. Slickrock Upstream Site, pool viewed from above. The red circle indicates location of staff gage. Surveyed pool is located in general area between red circle and large white rocks. Photos are taken post-release (7/6/17), with right side of photos downstream end.

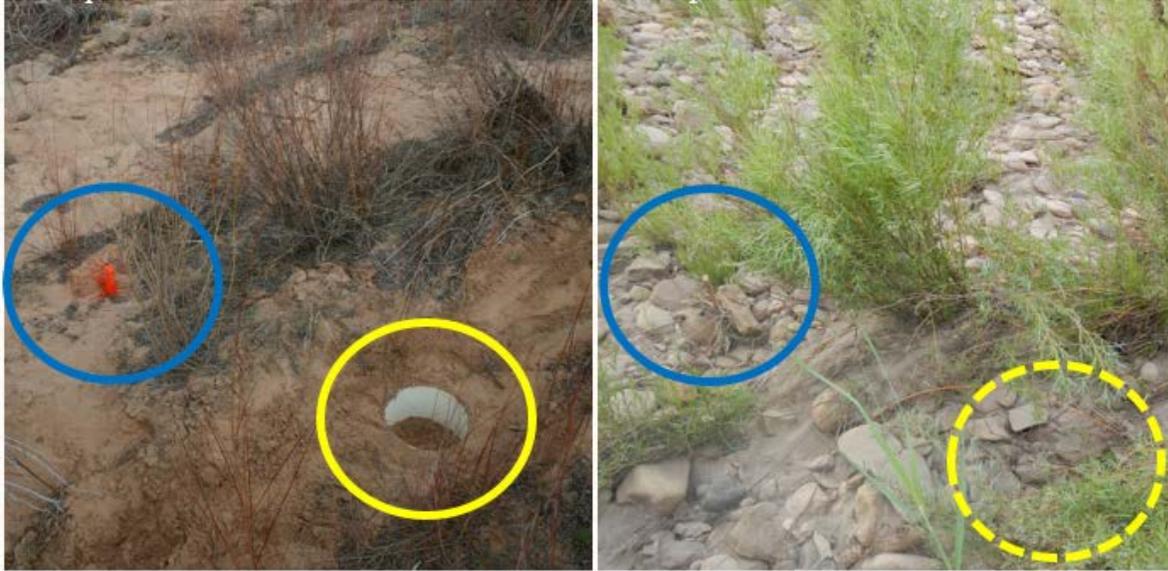
Figure 26. Slickrock Downstream sediment trap and erosion stake; pre-release photo on left (3/22/17), and post-release photo on right (7/6/17). Note the scouring of fine material observed with the orange erosion stake circled in blue between pre- and post-release. It appears that strong flows ripped out sediment trap pre- versus post-release.

Three erosion/scour stakes were installed at this site in the survey area, and all showed floodplain scour from 0.2 to 0.5 feet (Figure 26 and Figure 27). Scour consisted of removing fines, and mobilizing smaller cobbles from this low-floodplain environment. Sediment traps were installed using 6-inch PVC cut and dug into the floodplain in an attempt to document materials transported across the floodplain, but all traps were scoured from the floodplain so no data were acquired. Comparisons of painted patches/frames (0.5-meter square) pre- and post-release showed cobble movement in and out of the frames (Figure 28), and visually support the particle size analyses showing coarsening of the floodplain as fines were removed. Because the survey was conducted in a low-floodplain area, it was subjected to relatively high energy and is the best surrogate for processes that occurred in active in-channel sites. In that sense, these data support the objective of cleaning fines from cobbles to enhance spawning conditions for native fish. Wolman pebble counts at the Slickrock Downstream Site (Figure 29 and Figure 30) illustrate the coarsening of sediments, i.e., the removal of sand, silt, and clay.

- At the Slickrock Downstream Site, erosion stakes on a low floodplain, high energy site showed significant scour. Some cobble movement was observed into and out of the painted patch, indicating that larger particles were also mobilized with the managed release.

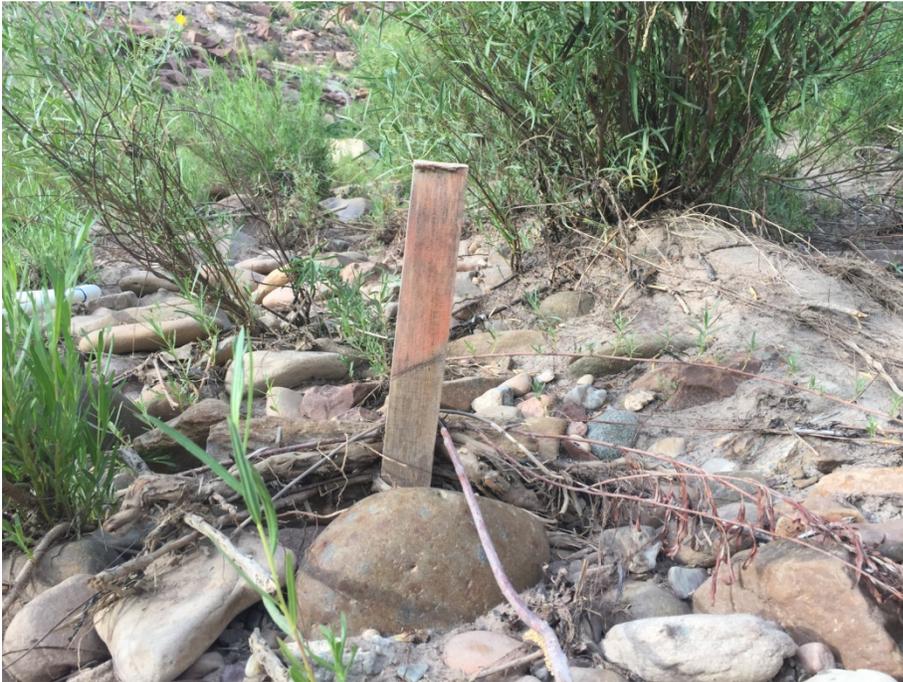
Figure 27. Post-release scour on low floodplain at Slickrock Downstream site. Stake painted to depth installed pre-release (3/22/17). Approximately 0.5 feet of material was scoured from this location.

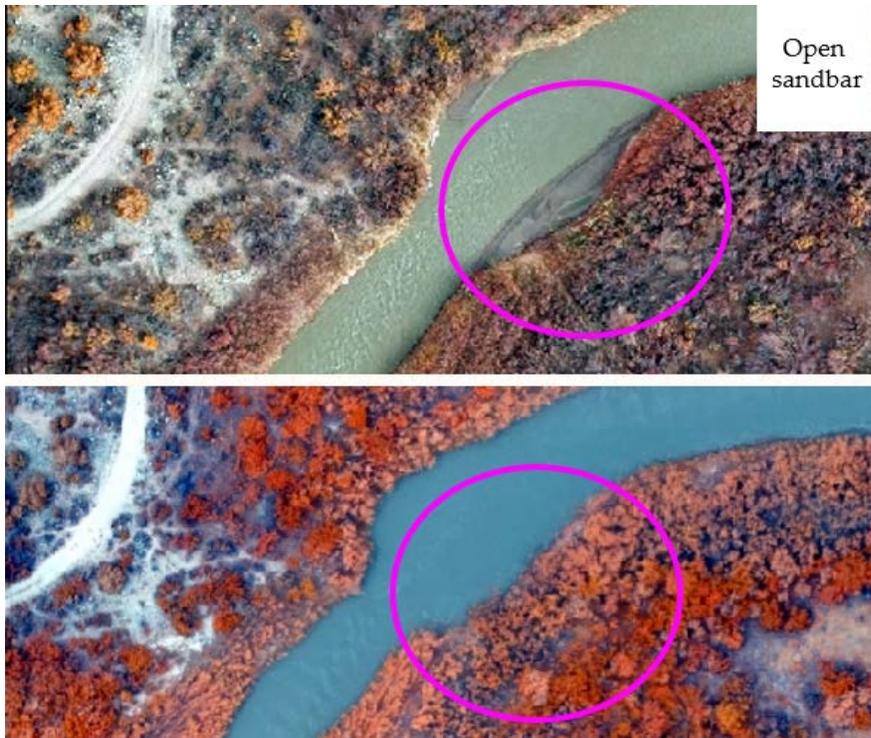
Figure 32. BLM Rec (Big Gypsum) Site, showing area of cross-section survey pre-release in March (top), and post-release in June (bottom) 2017.

The BLM Rec (Big Gypsum) Site is a semi-confined, alluvial valley type, with alluvial deposition and a narrow floodplain (Figure 32). It has a meandering riffle-pool system, streambank erosional processes, and a productive riparian community.

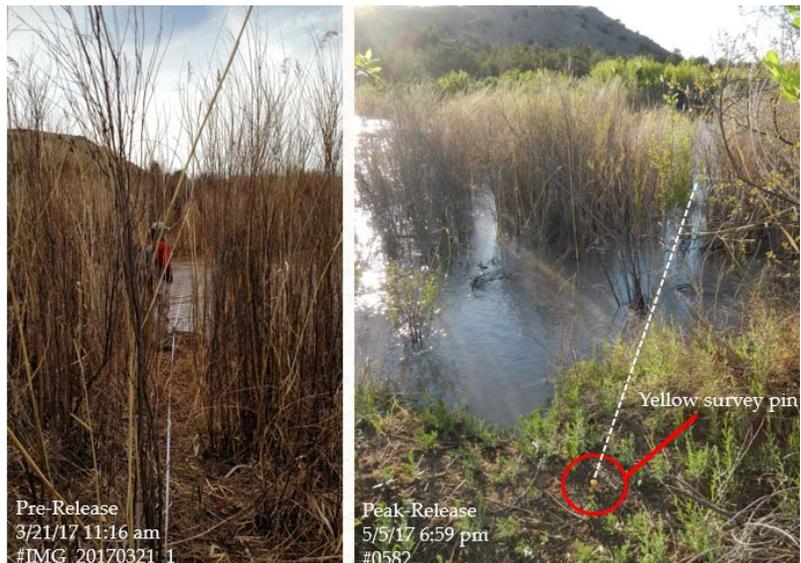
Figure 33. BLM Rec (Big Gypsum) Site, showing cross-section line pre-release (3/21/17; on left), and estimated line trajectory if it had been run at peak-release (5/5/17; on right), 2017.

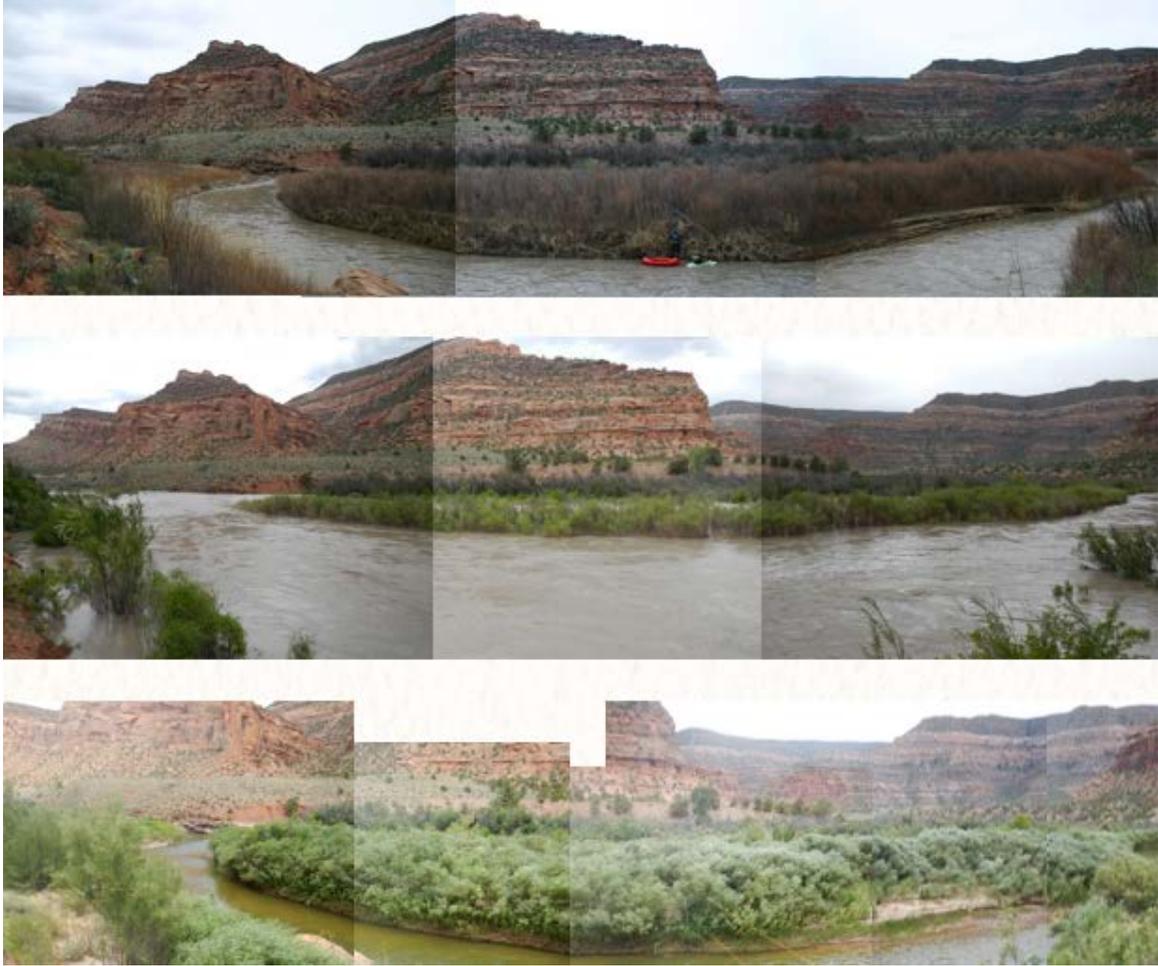
Figure 35. Overview of Bedrock site pre-release (3/23/17; top), peak-release (5/6/17; middle), and post-release (7/7/17; bottom).

The Bedrock Site is a semi-confined, alluvial valley type, with alluvial deposition and a narrow floodplain. It is a meandering, riffle-pool system, with streambank erosional processes, and a productive riparian community (Figure 35).

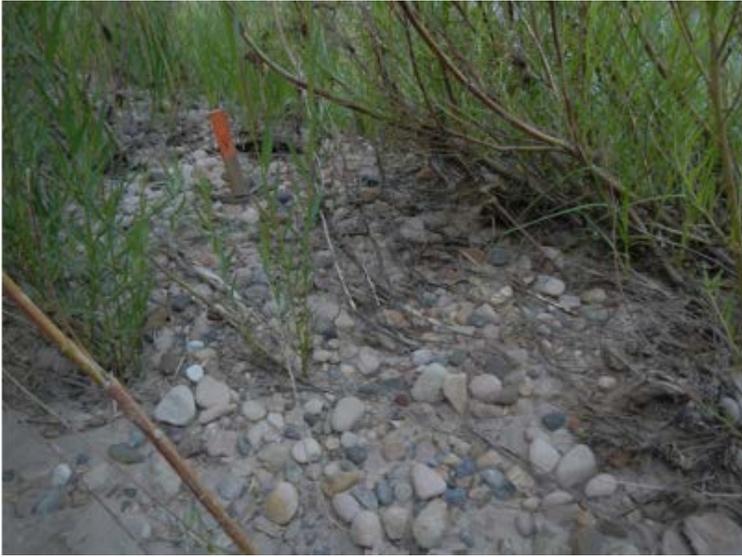
Figure 39. Bedrock erosion stake monitoring, a close-up view of stake #1 post-release. The bare wood below the blaze orange is the depth of scour.

At the Bedrock site there was not much change in the channel but some scour did occur (Figure 37 and 38). Deposition of material occurred on the right bank (Figure 39). An estimated 260 tons of material at this site was eroded and released into the river (based on bank loss calculations). There was good mobilization of material. Riffle habitat was reset, and water accessed the floodplain (Figure 40).

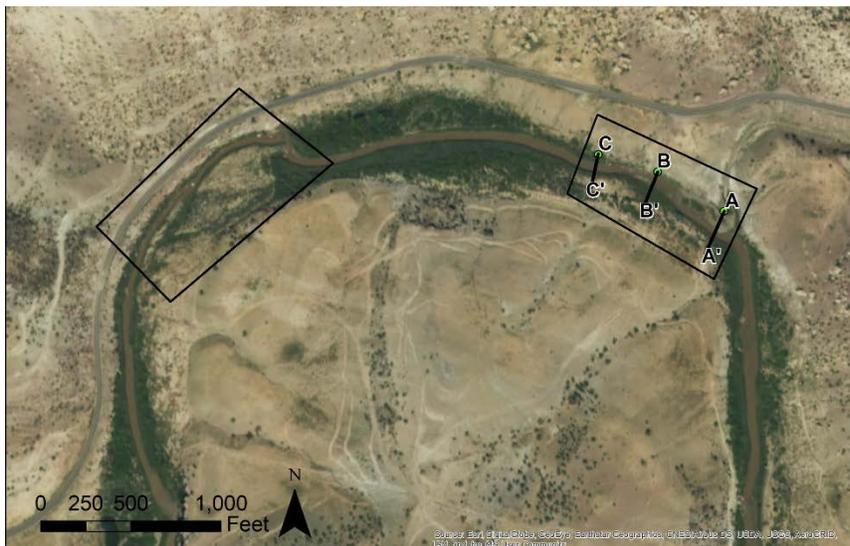
Figure 41. The Slickrock Downstream site (left) and the Fort Lewis College site farther upstream showing cross-sections analyzed with structure from motion technology.

Additionally, the researchers conducted drone-derived photogrammetry (3-D floodplain surveys) pre- and post-release at both the FLC Slickrock site, and at the Slickrock Downstream site (one of the five newly established ecological monitoring sites). A pre-release 3-D floodplain survey was also conducted at the BLM Rec (Big Gypsum) Site, but a post-release survey has not yet been conducted at this site (researchers could not collect data post-release during the 2017 growing season extensive vegetative cover at this site was predicted to significantly reduce the clarity of elevation data collection efforts). Using the data collected at the FLC Slickrock site and the Slickrock Downstream site, they created 3-D elevation models for these two sites to compare how the broader floodplain and stream-marginal environments changed as a result of overbank flows, including assessing scour and deposition on stream-marginal floodplains, emergent in-channel bars, and side channels. At the Slickrock Downstream site, comparison of pre- and post-release elevation models showed minimal lateral bank erosion, but up to 2 feet of incision in a pre-existing side channel. It also revealed deposition of up to 3 feet of sand on the floodplain, with the greatest deposition in a bar proximal to the channel amongst the willows.

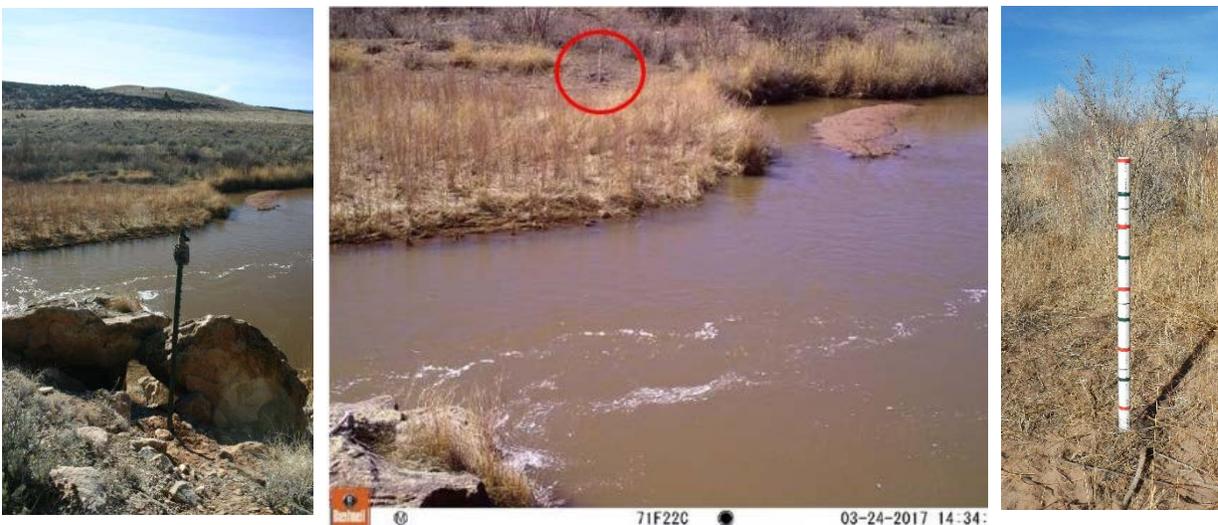
Figure 43. Installation of staff gage and wildlife camera at the Slickrock Upstream site in March 2017. From left to right: installed camera, shot from camera at time of installation (staff gage circled in red), and staff gage close-up (post-release).

Wildlife cameras and staff gages were installed at each of the five new ecological monitoring sites between March 20-24, 2017 to capture important changes in river flow stage height prior to, during, and after the 2017 McPhee Reservoir managed release (see Figure 43 for example). One Bushnell wildlife camera and one staff gage were installed at each site, with the exception of the Dove Creek site, where two staff gages were installed. Wildlife cameras were attached to stable objects or installed posts to capture images at regular intervals of the staff gages. Staff gages were typically installed across the river (on the opposite river bank) from the location of the wildlife cameras, with one exception (Dove Creek Pumps). All staff gage locations were benchmarked to the local datum, so that data could be correlated with other flow and survey data. For detailed information on locations and installation information of the wildlife cameras and staff gages, see *Appendix 3: Ecological Monitoring Sites – Staff Gage and Wildlife Camera Installation*.

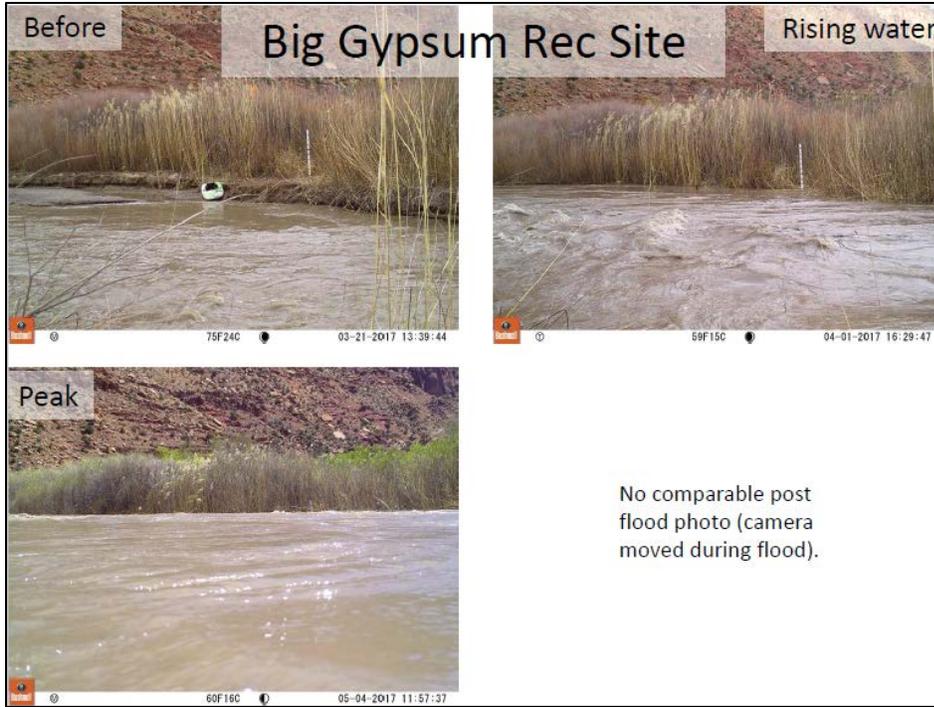
Figure 46. BLM Rec (Big Gypsum) staff gage at pre-release, rising water, and peak-release.

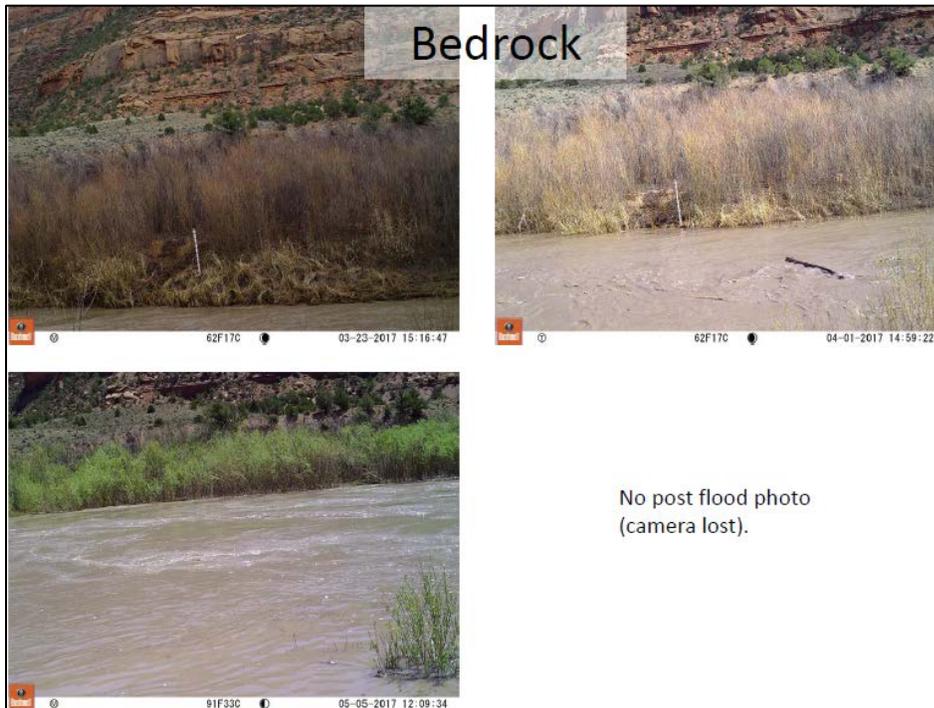
Figure 47. Bedrock staff gage at pre-release, rising water, and peak-release.

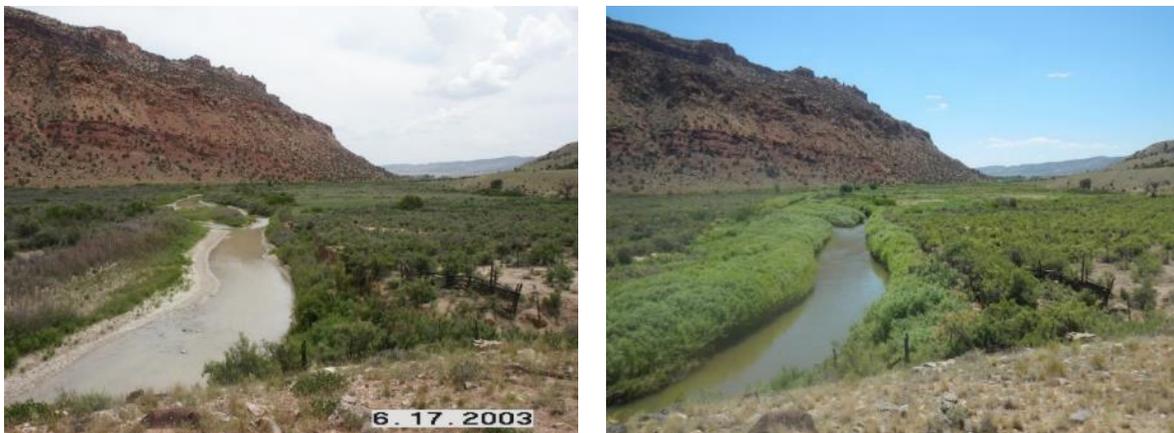
Figure 57. Historic Big Gypsum Photo Point #2 taken in 2003 (6/17/03; top) and 2017 (6/26/17; bottom). Note substantial increase in willow along bank. It should be noted that flows are higher in 2017, so some difference in photos is due to this.

The following figures show two of the 2003 versus 2017 historic vegetation photo point comparisons. To view all six comparisons, see Appendix 4. The most obvious change in both photo sets shown below is the extensive willow growth that has overtaken the river banks.

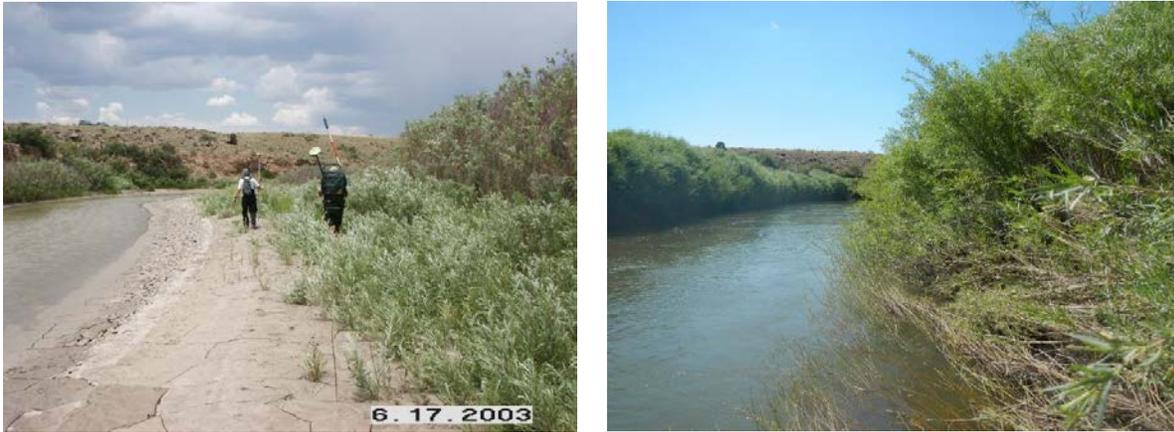
Figure 58. Historic Big Gypsum Photo Point #6 taken in 2003 (6/17/03; top) and 2017 (6/26/17; bottom). Notice how willow has filled in the bank over time. As above, it is important to note that flows are higher in 2017, so some of the observed difference is due to this.

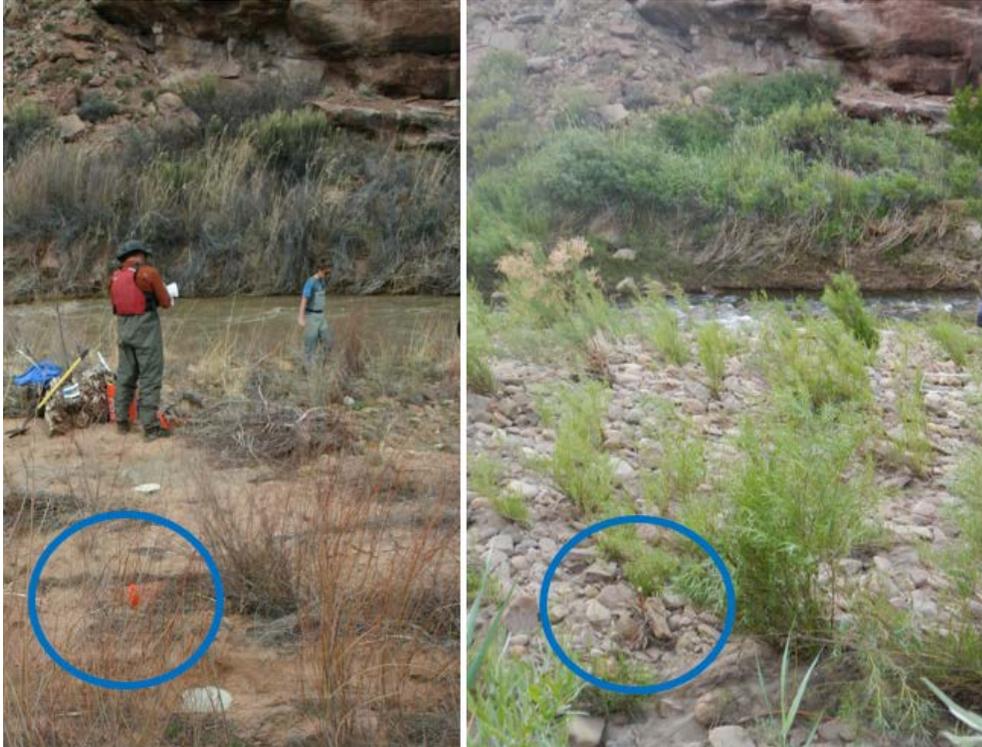
Figure 59. Erosion stakes at Slickrock Downstream (Below Disappointment Creek) Site; close-up of sediment scouring (taken from river left, standing on bar), pre-release 3/22/17 on left, post-release 7/6/17 on right. Note the scouring that has taken place pre- versus post-release.

At the Slickrock Downstream Site, we observed noticeable evidence of scour in the survey area (Figure 59). We also observed evidence of scour at the Bedrock Site (Figure 60).

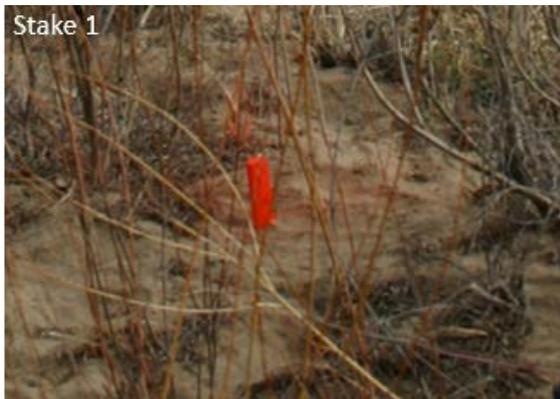
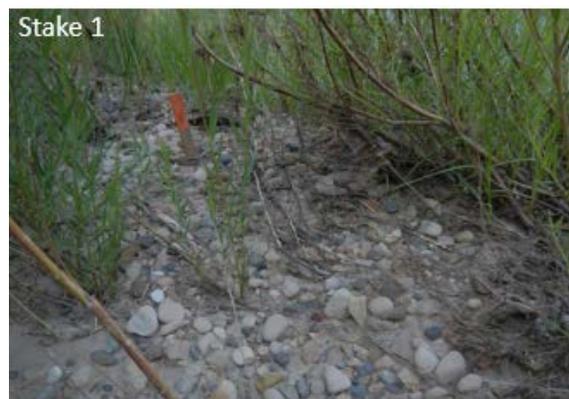
Figure 60. Point bar at Bedrock Site, close-up of sediment scouring (Erosion stake #1, river left), pre-release 3/23/17 on left, and post-release 7/8/17 on right.

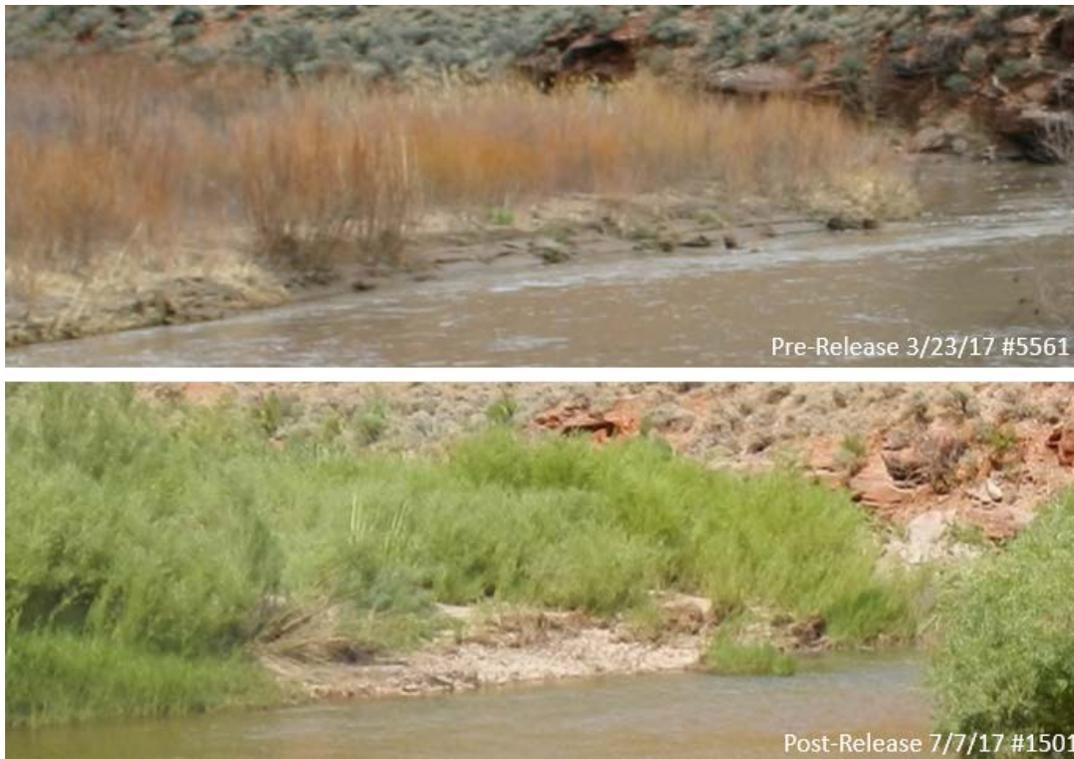
Figure 61. Point bar at Bedrock Site, upstream view of some bank/sediment scouring in same general area as above photo set (taken from river left). Photo at top pre-release (3/23/17; #5561); photo at bottom post-release (7/7/17; #1501).

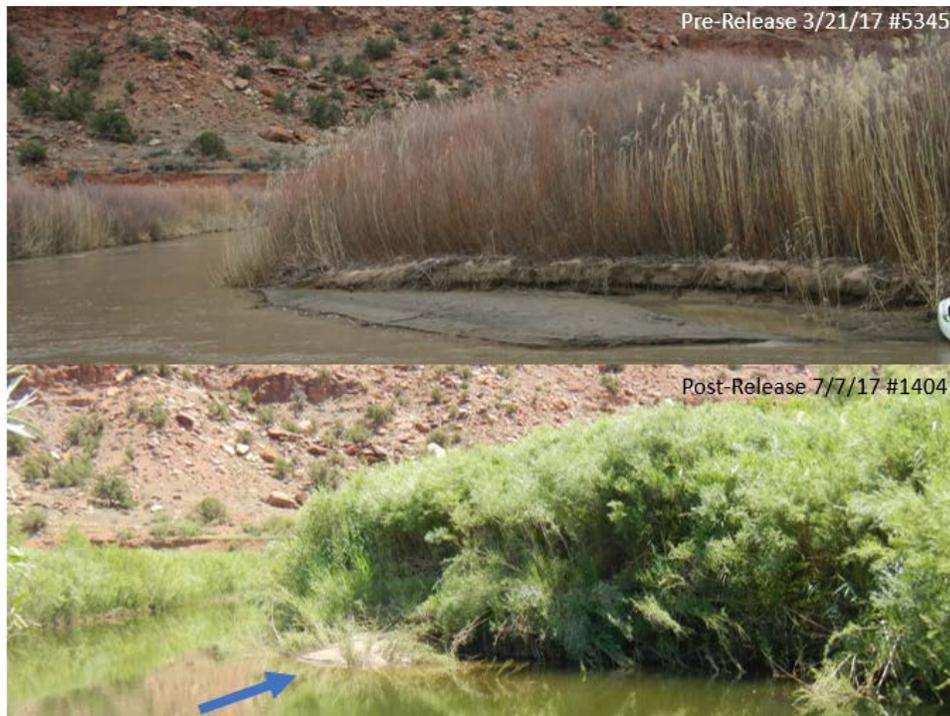
Figure 63. Young willow quickly colonizing recently bare ground at the BLM Rec (Big Gypsum) site post-release, indicated by blue arrow. Photos taken pre-release (3/21/17; top) and post-release (7/7/17; bottom) from river left, looking downstream.

In other areas where new sediment was deposited to create new bare areas lower on the river bank/floodplain (closer to rivers' edge), both willow and Phragmites (*Phragmites australis*) were observed to quickly colonize (or re-colonize) these bare areas. See Figure 63 below for an example of young willow colonization at the BLM Rec (Big Gypsum) Site. Also see the next subsection for evidence of Phragmites colonization of newly bare areas (resulting both from scour, and from new sediment deposition).

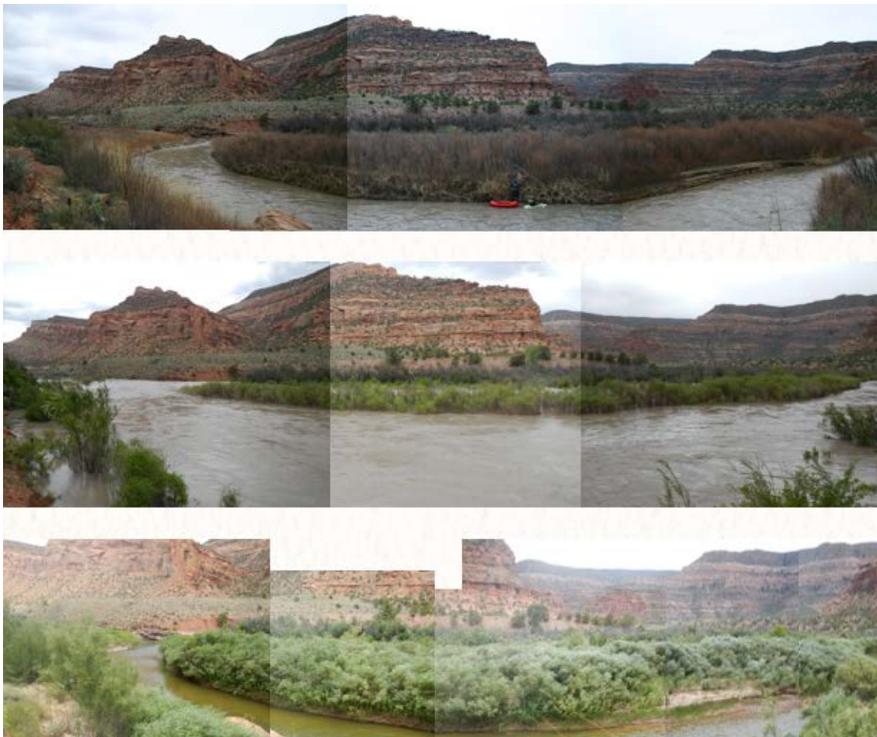
Figure 64. Thick willow armoring bank at main Bedrock Site, with photo series appearing to show little noticeable change in willow density with flooding. Photos taken from river left pre-release (3/23/17; top), peak-release (5/6/17; middle), and post-release (7/7/17; bottom).

At the main Bedrock Site, photo comparison appeared to show very little removal of willow with 2017 flooding in one area, but some willow removal was obvious in another area (see figures below). In general, however, very little noticeable willow removal was observed at the five new ecological monitoring sites.

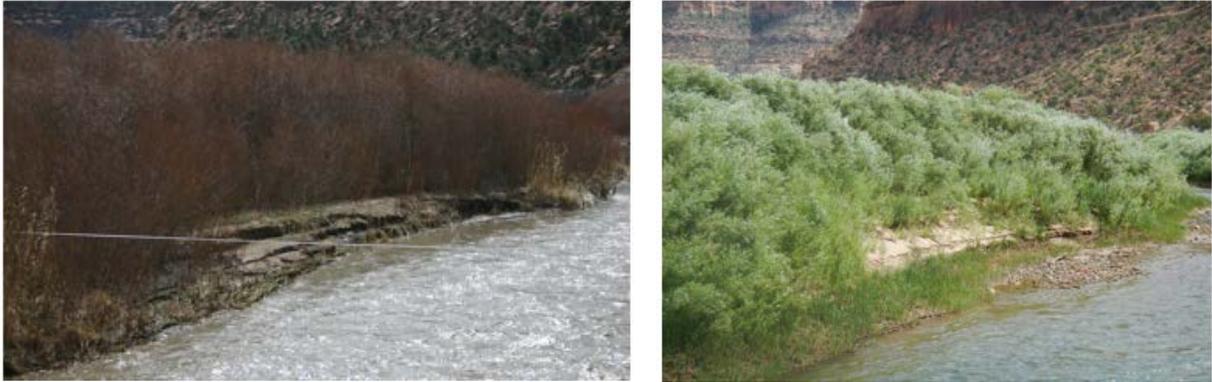
Figure 65. Close-up of upstream portion of above photo series at main Bedrock Site, appearing to show little noticeable change in willow density with flooding (taken from river left). Pre-release on left (3/23/17), post-release on right (7/7/17).

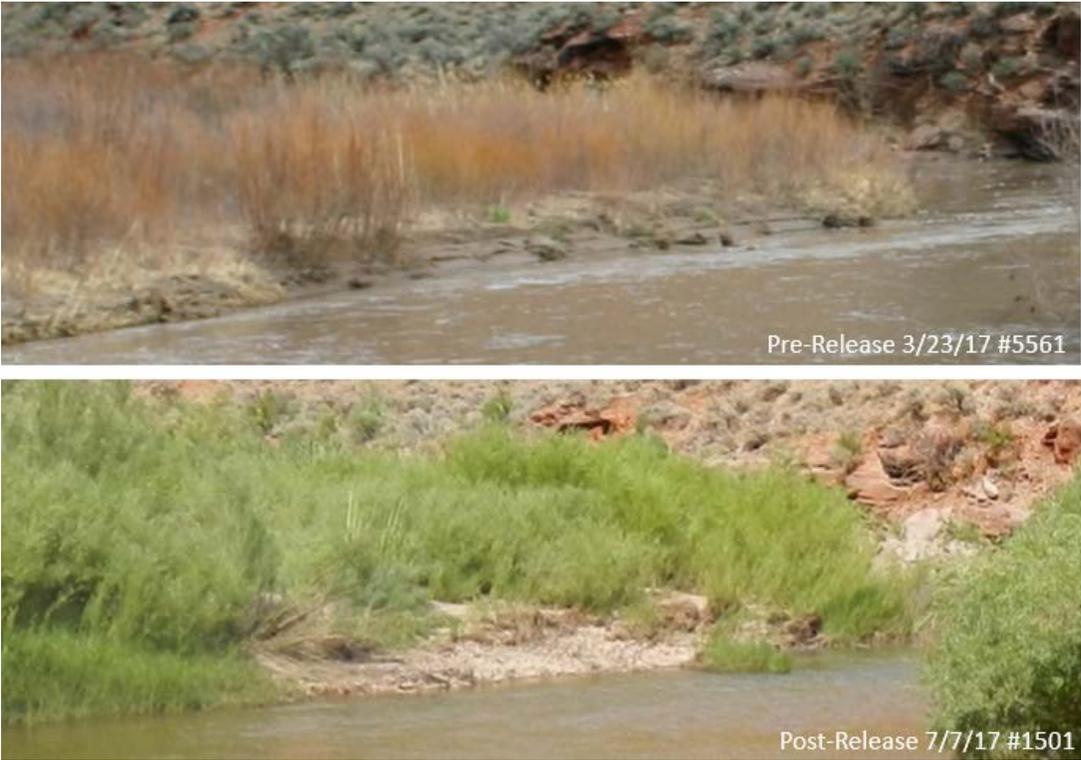
Figure 66. Point bar at Bedrock Site, upstream view of area that saw a small amount of removal of willow with flooding (taken from river left).

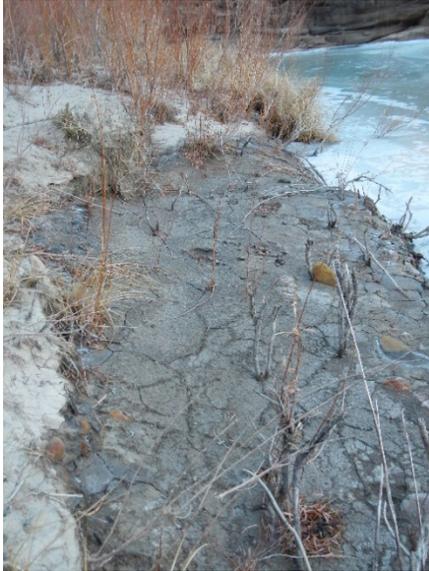
Figure 67. Close-up of point bar at Bedrock Site that saw some removal of willow with flooding (taken standing on bar). However, it appears that regrowth of willow is occurring from remaining willow stumps. 12/29/17, #1972

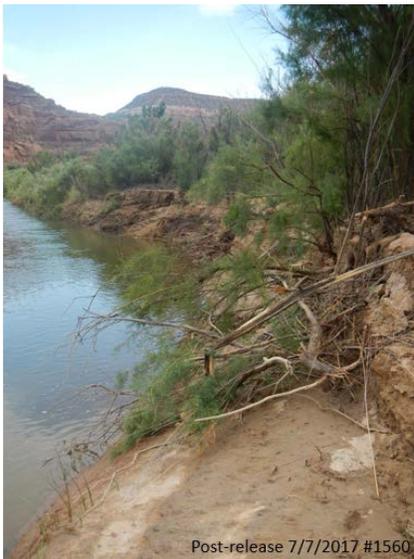
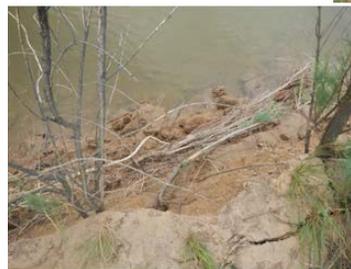
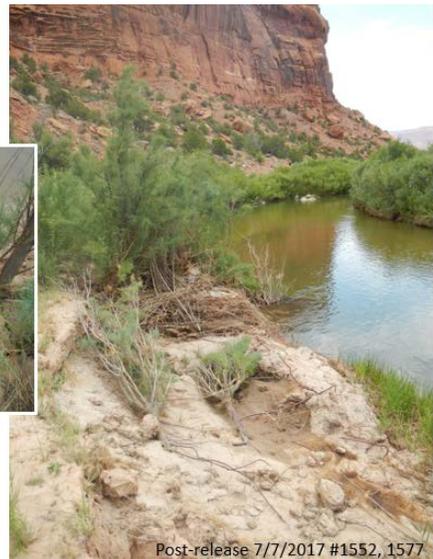
Figure 68. At site just upstream from main Bedrock site; tamarisk loss with bank erosion. Photos taken from river left, post-release (7/7/17).

Just upstream of the main Bedrock Site, however, a separate monitoring site was established. At this site, some limited loss of 'armoring' vegetation (tamarisk) along the river bank was observed (see below photos).

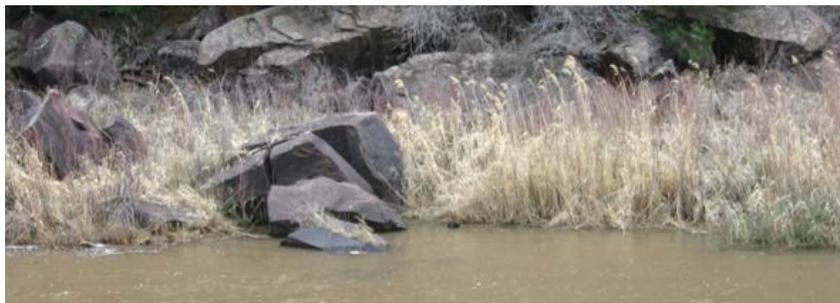
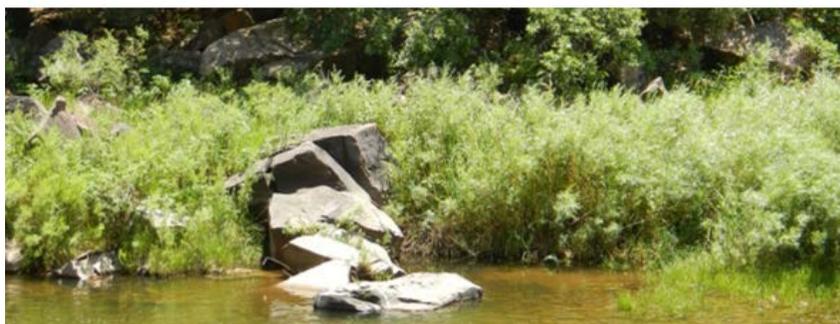
Figure 69. Phragmites population (mixed with willow) at the Dove Creek site, pre- versus post-release 2017 (taken from river left). Pre-release at top (3/20/17), post-release at bottom (7/8/17).

An existing Phragmites population (mixed with willow) at the Dove Creek site did not appear to change noticeably in photos taken pre- versus post-release 2017; or if some Phragmites was removed willow may have filled in the above ground gaps (Figure 69).

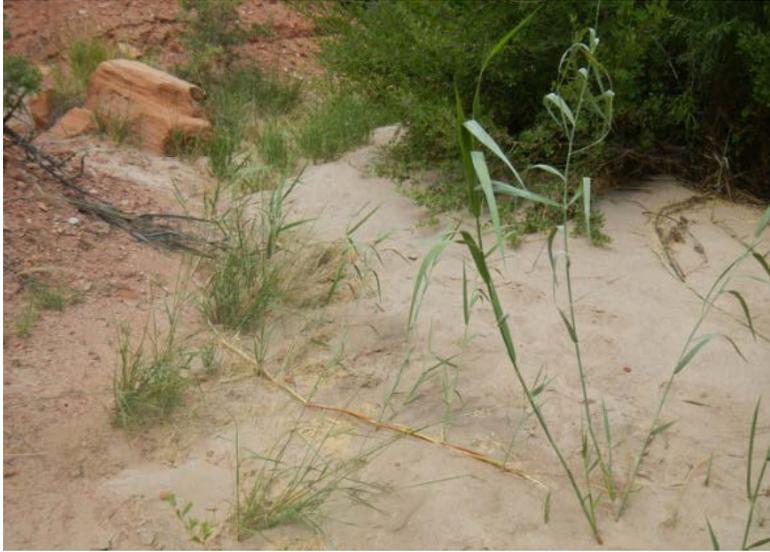
Figure 71. New sediment accumulation at main Bedrock Site, with partially buried Phragmites quickly sending out new runner (stolon) to recolonize new bare area (photo taken from/on river left bank). Post-release 7/7/17, #1536.

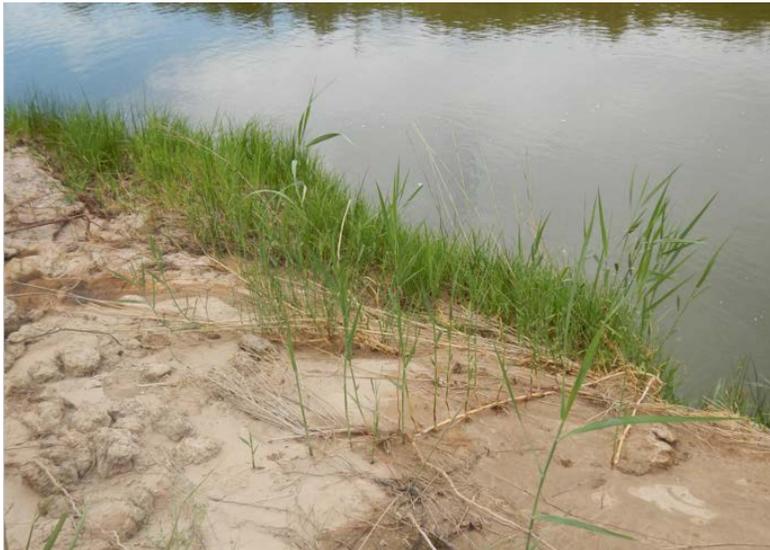
Figure 72. Bank erosion at monitoring site just upstream from main Bedrock Site, with Phragmites runners quickly climbing the bank to recolonize new bare area (photo taken from/on river left bank). Post-release 7/7/17, #1559.

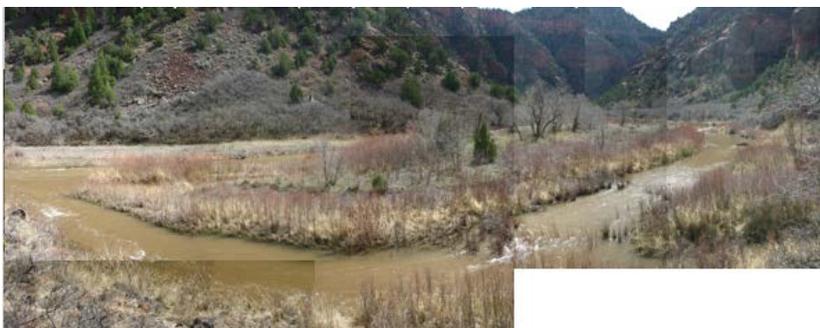
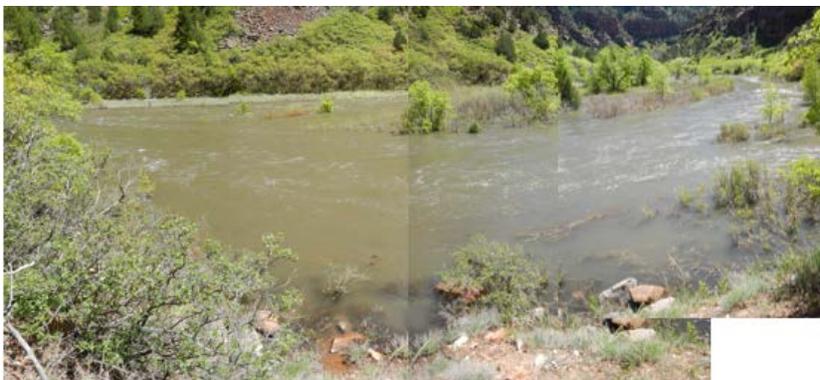
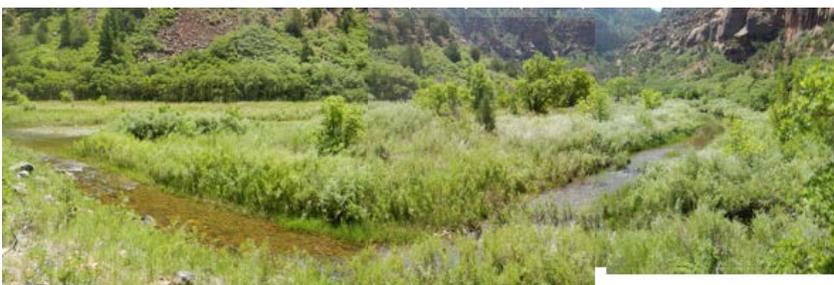
Figure 73. 2017 pre (3/20/17), peak (5/5/17), and post-release (7/8/17) photo series of island just upstream of Dove Creek site (taken from river left).

One site where it will be interesting to track changes over time is at the Dove Creek site. A large island just upstream of the main site is covered with willow, some cottonwood, and a combination of other riparian to mesic vegetation. In 2017, the island was mostly flooded during peak release (Figure 73).

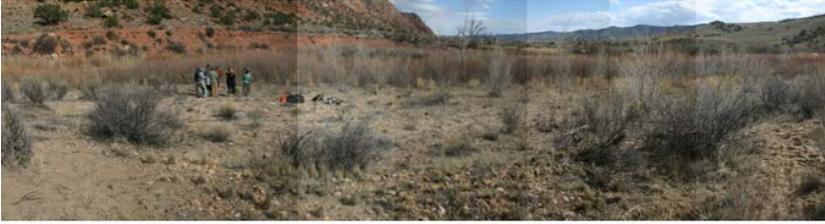
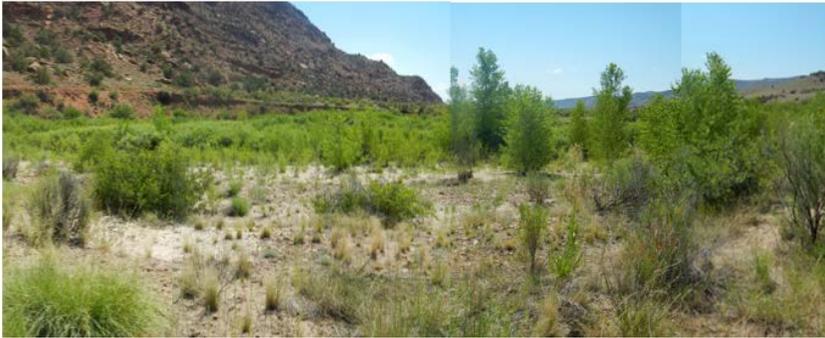
Figure 74. 2017 pre-release (3/21/17, top) and post-release (7/7/17, bottom) photo series of point bar at the BLM Rec (Big Gypsum) site.

A large point bar at the BLM Rec (Big Gypsum) site also appears to be currently maintaining primarily riparian and mesic species (Figure 74). The point bar was mostly flooded at peak release in 2017.
