Lower Dolores River
2017 McPhee Reservoir
Managed Release
Ecological Monitoring & Evaluation
Volume 2: Detailed Methods and Findings
February 2018

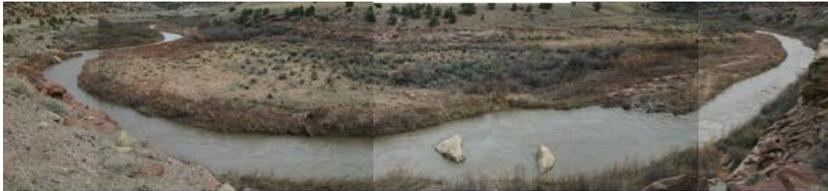
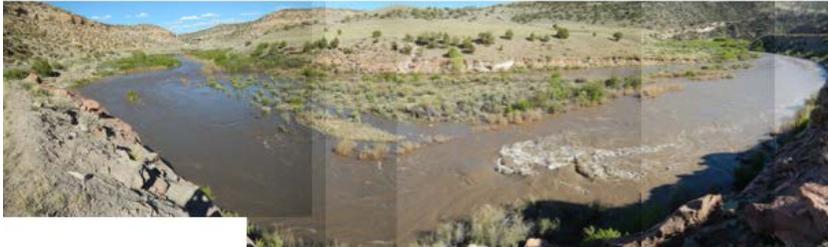
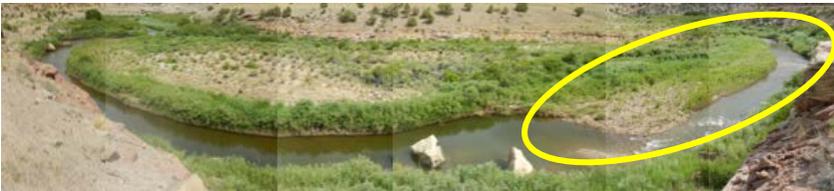
Figure 75. Slickrock Downstream (Below Disappointment Creek) Site pre-release (3/22/17), peak-release (5/5/17), and post-release (7/6/17). Photos taken from river right.

Another site where it will be interesting to track the changes over time is at the Slickrock Downstream (Below Disappointment Creek) site, where rubber rabbitbrush and other mesic species currently dominate much of what was once an active mid-channel bar. Much of this area was flooded in 2017, but based on photo comparison, there does not appear to be a noticeable reduction in this vegetation because of flooding (Figure 75).

It will also be interesting to watch the focus area of our data collection at this site (circled in yellow above in Figure 75). This area is currently dominated by willow and more riparian species, and we are not currently seeing encroachment of more mesic/xeric species (also see photo series below). However, this area likely sees more regular flooding currently, even without release manipulation.

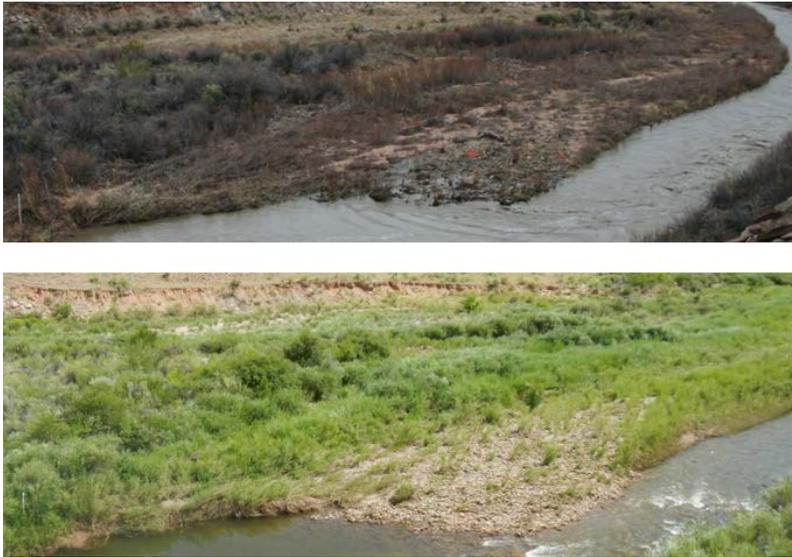
Figure 76. Close-up of survey area at Slickrock Downstream (Below Disappointment Creek) Site taken from river right, pre-release (3/22/17; top) and post-release (7/6/17; bottom).

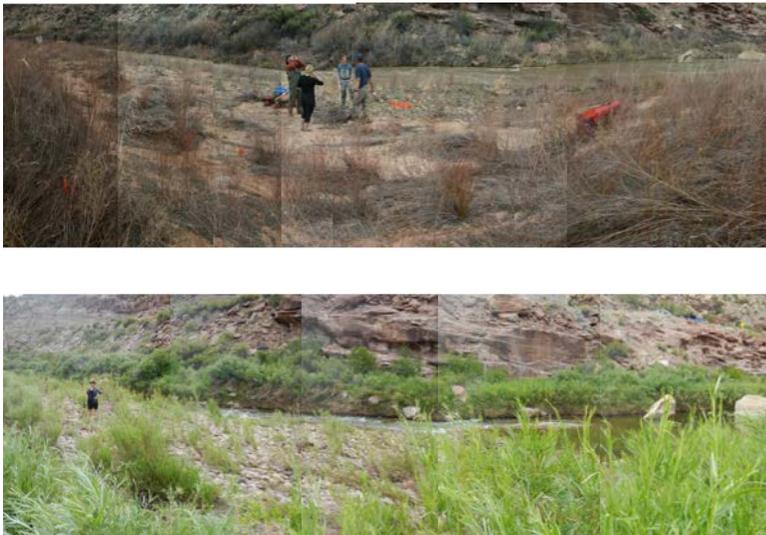
Figure 77. Close-up of survey area at Slickrock Downstream (Below Disappointment Creek) Site, taken from river left standing at edge of survey area, pre-release (3/22/17; top) and post-release (7/6/17).

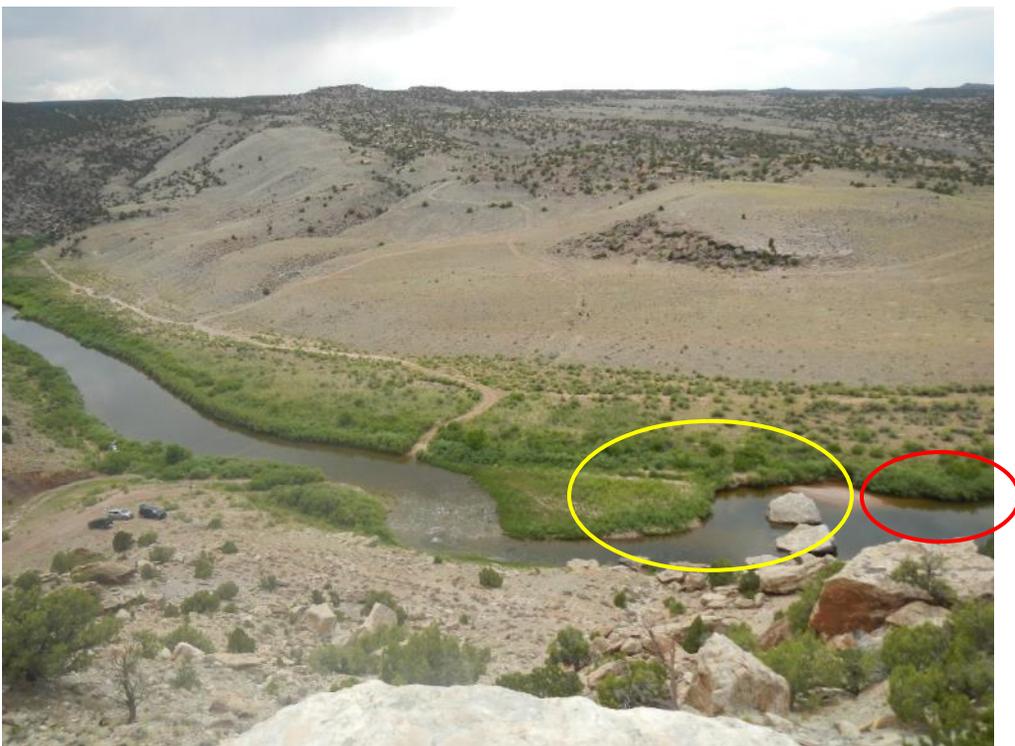
Figure 78. Two cottonwood recruitment survey areas at Slickrock Upstream Site (circled below). Photo from post-release, 7/6/17, #1190.

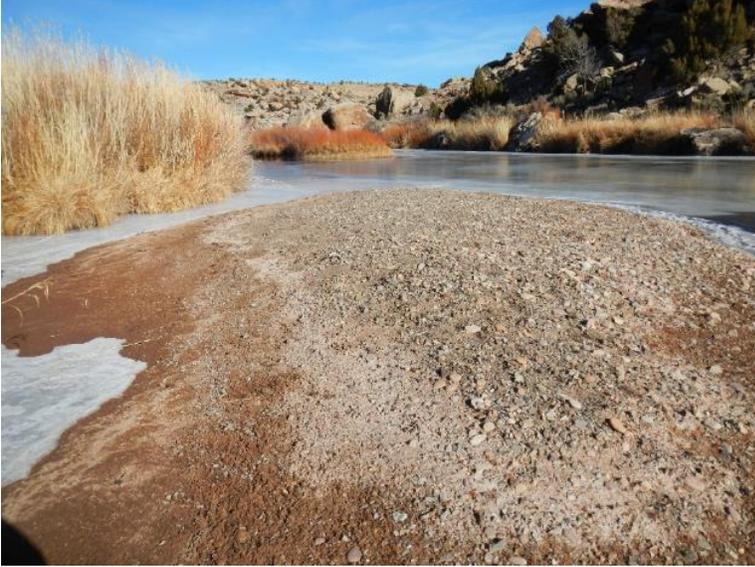
Figure 79. Closeup of new small depositional survey area at Slickrock Upstream Site (circled in red above).
12/29/17, #1897

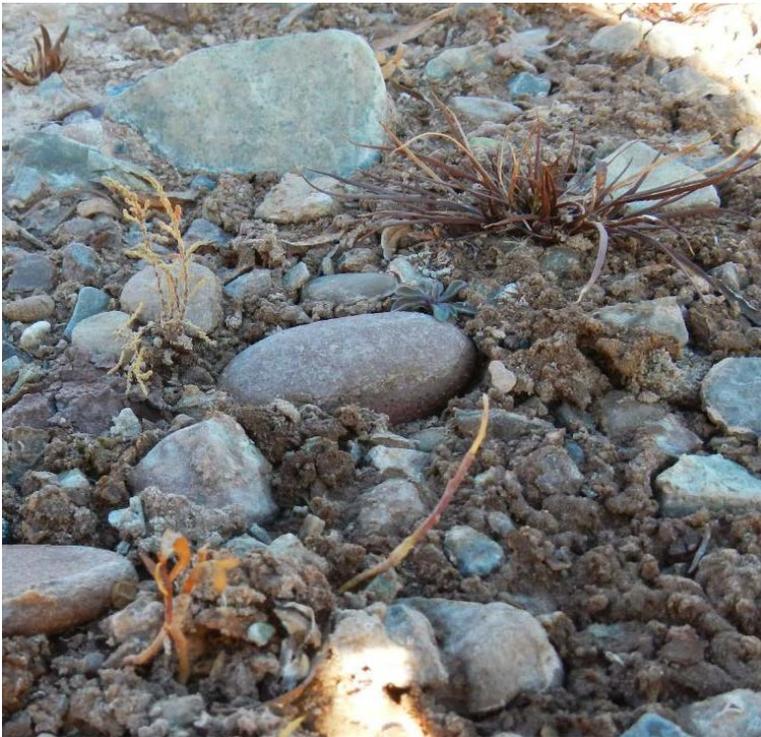
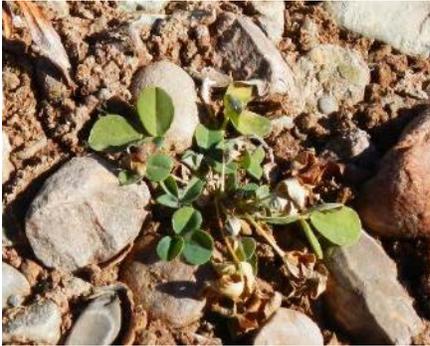
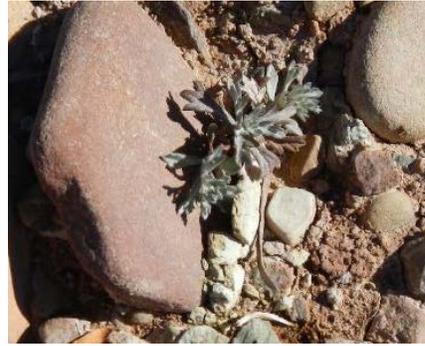
a. Seedlings observed at Slickrock Upstream site, 12/29/17, #1899. Photo is a close-up.

b. and c. Additional seedlings at Slickrock Upstream site. 12/29/17, #1900, and #1901

Figure 80 (a-c). Closeups of some of the young seedlings found on new small depositional survey area at Slickrock Upstream Site.

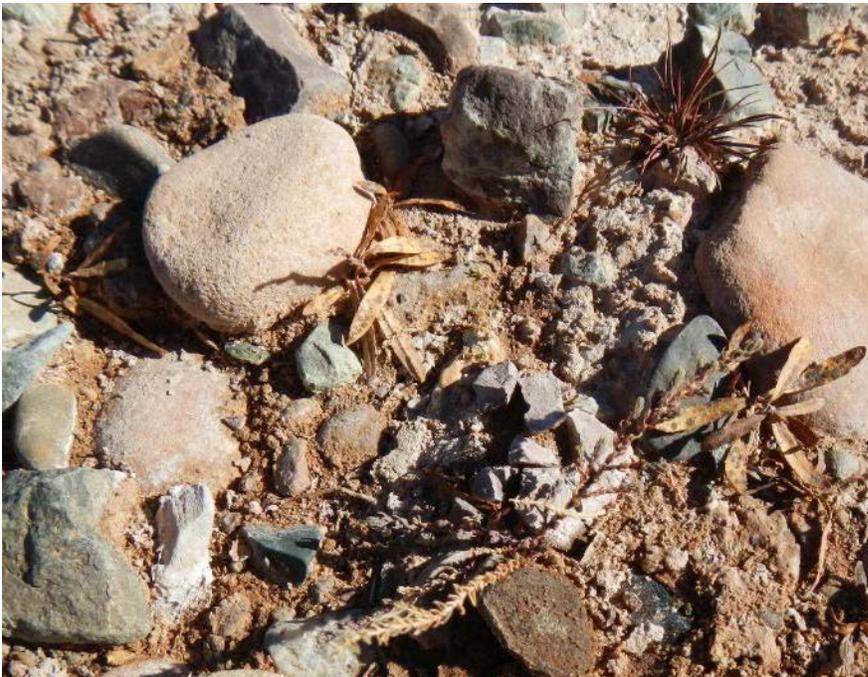
Figure 81. Another closeup of young seedlings found in this Slickrock Upstream survey area. Note numerous willow seedlings. 12/29/17, #1902

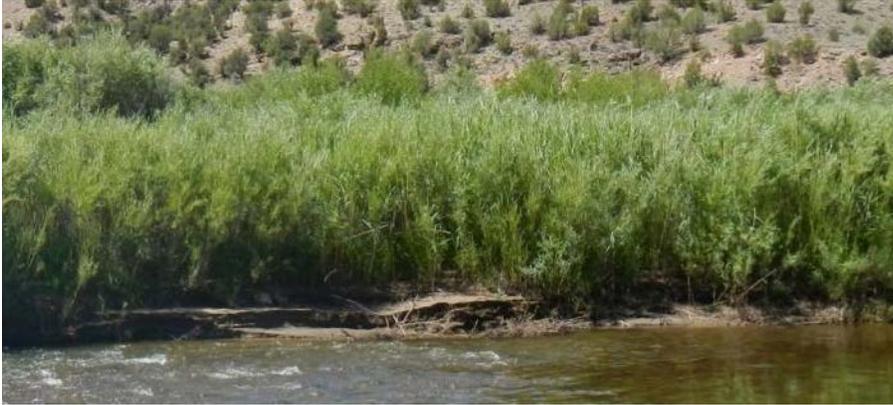
Figure 82. Scoured Phragmites bank survey area at BLM Rec (Big Gypsum) Site, 7/7/17, #1366.

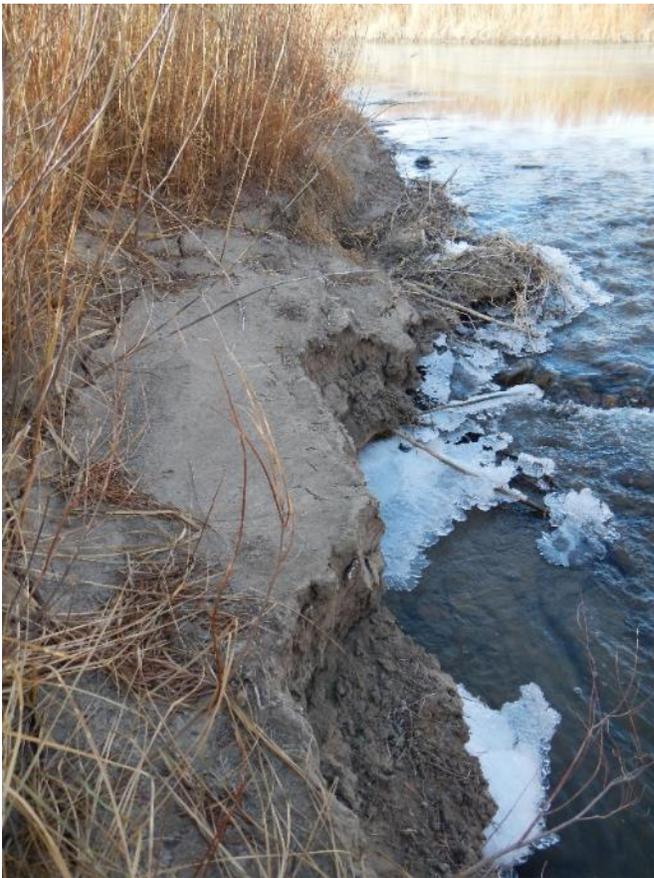
Figure 83. Closeup of scoured Phragmites bank survey area at BLM Rec (Big Gypsum) Site, 12/29/17, #1920. No young seedlings found; only vegetatively spreading Phragmites.

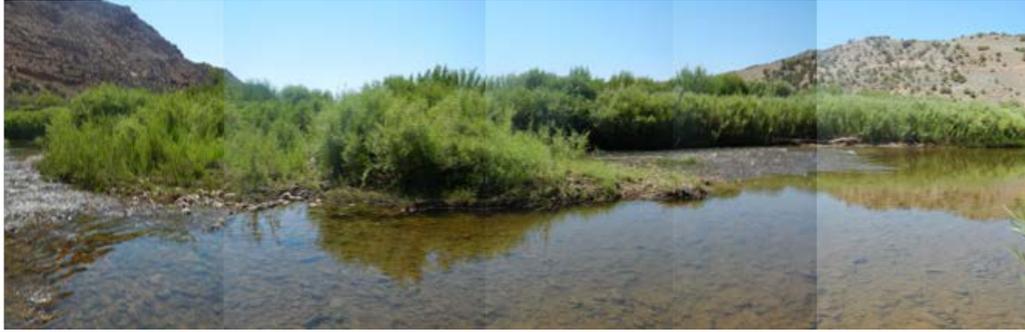
Figure 84. 'The Island' survey area at BLM Rec (Big Gypsum) Site, 7/7/17, #1355-1365 various photos merged.

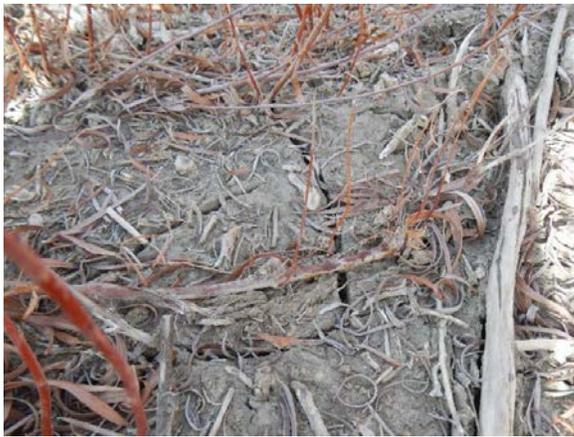
Figure 85. Closeup of willow spreading vegetatively in this area, 12/29/17, #1927.

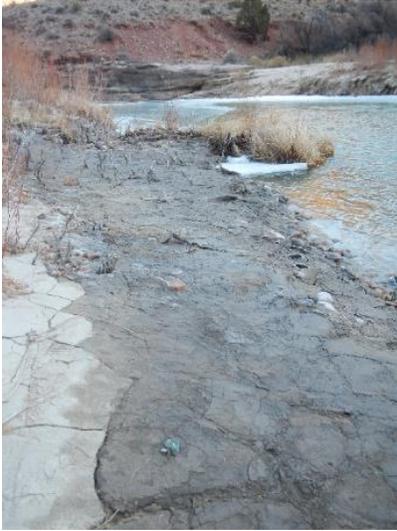
a. One new native seedling in foreground, 12/29/17, #1970

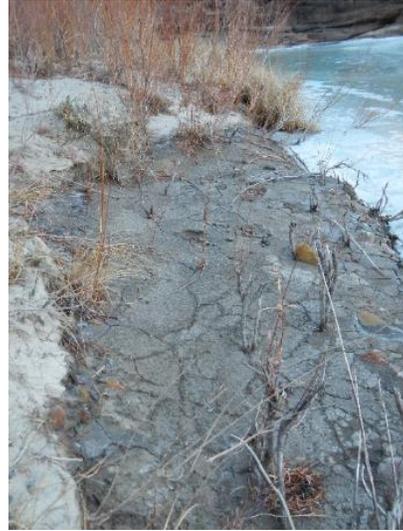
b. Closeup of native seedling, 12/29/17, #1970

c. Regrowth from willow stumps 12/29/17, #1972

Figure 86 (a-c). Closeup of newly scoured open area (survey area #2) at Bedrock Site.

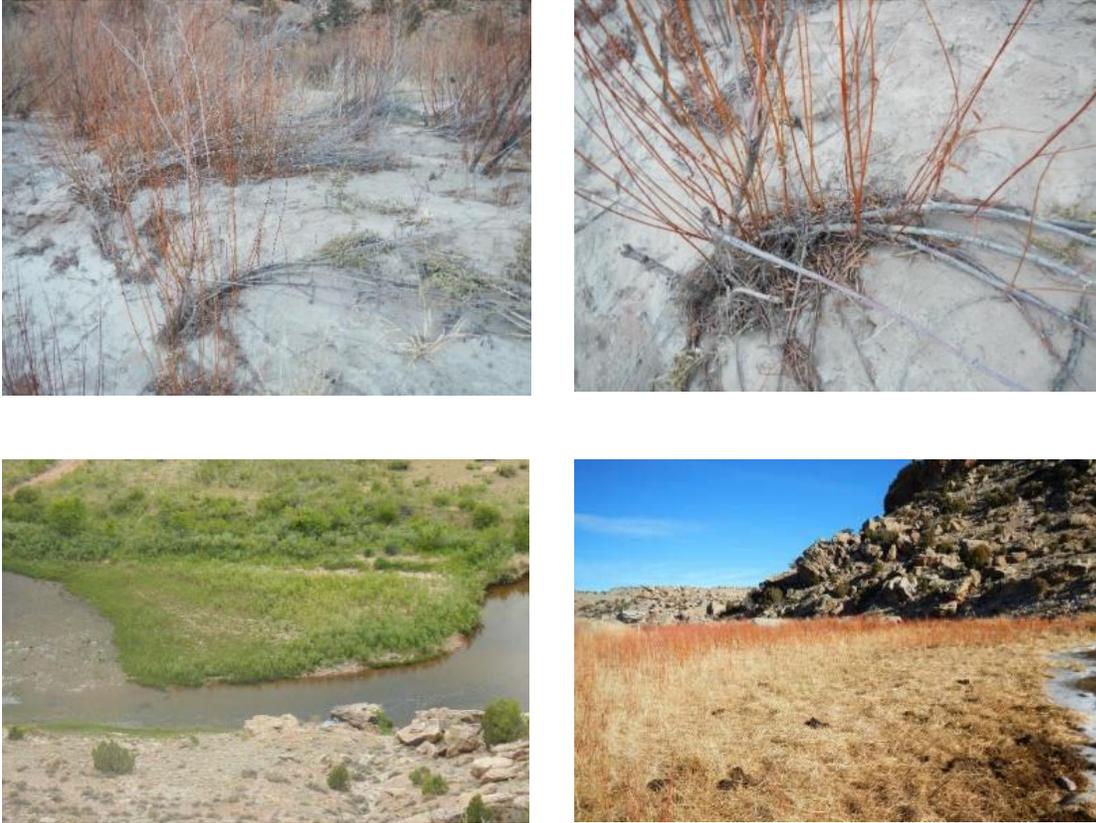
Figure 87 (a-d). Examples of willow and grass spreading into newly scoured/depositional bare areas. Upper right and left photos: willows resprouting at Bedrock Site, 12/29/17, #1978,1979. Lower left: Slickrock Upstream Site diagonal bar post-release, 7/6/17, #1204. Lower right: Slickrock Upstream Site diagonal bar at the end of the growing season, 12/29/17, #1887

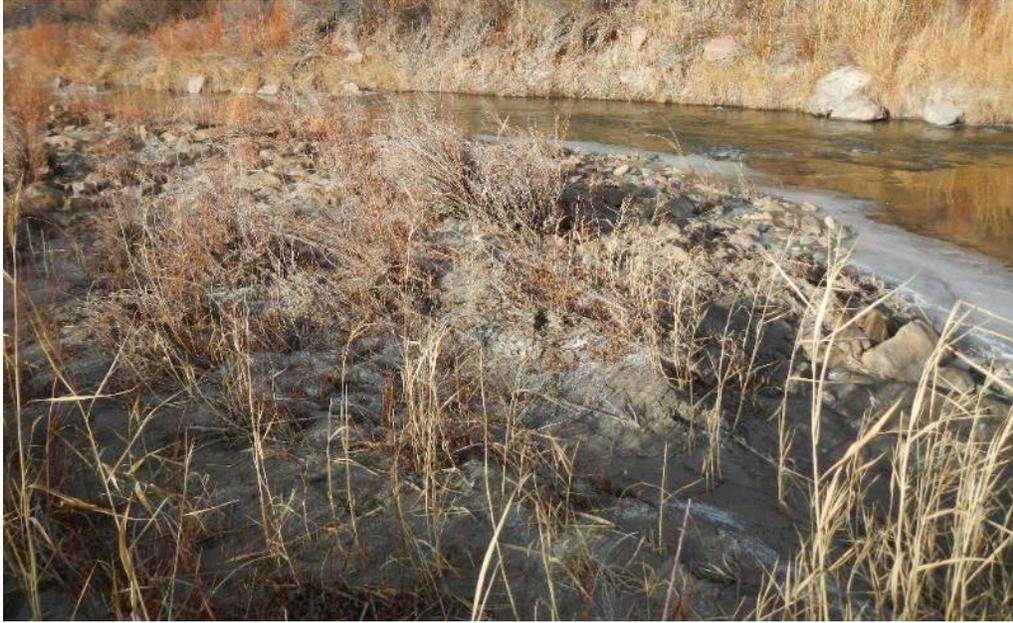
Figure 88. Accumulation of salts (white substance) on soil surface at the Slickrock Downstream site.

- Some sites appear to have a high accumulation of salts in/on the surface of the soils, and cottonwoods are not highly tolerant to saline conditions. For revegetation practices, Fremont cottonwoods in general are known to have a threshold salinity tolerance of 8 mmhos/cm, and a maximum salinity tolerance of 15 mmhos/cm. Threshold salinity tolerance is the level of soil salt concentration at which plant performance begins to be observably or measurably reduced. Maximum salinity tolerance is that level at which plant viability, growth and/or performance are severely or permanently curtailed (Sher et al. 2010). The photo below shows evidence of salt accumulation on the Slickrock Downstream site. Soil salinity levels on these monitoring sites have not been tested (See Figure 88).

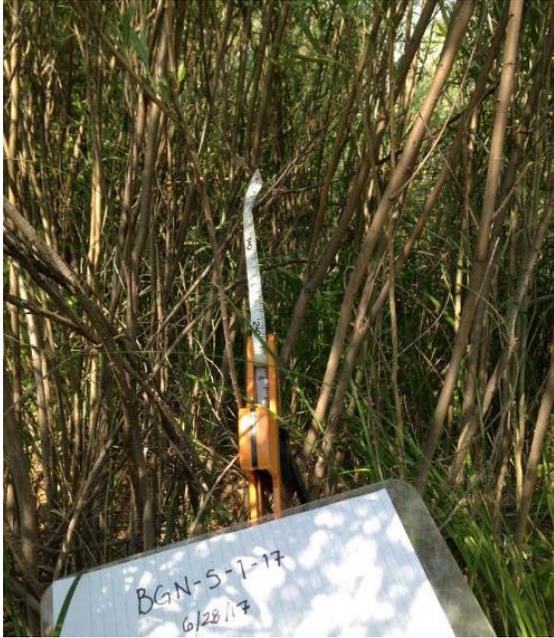
Figure 89. A willow transect along the Dolores River.

In 2010, vegetation transect monitoring occurred at select Slick Rock and Big Gypsum Valley sites along the Dolores River. Select transects were then re-sampled post-release in 2017. Willow stem density was determined in 1-square meter plots evenly spaced along transect lines by conducting counts of willow stems. Percent cover of bare ground versus vegetation litter was also determined.

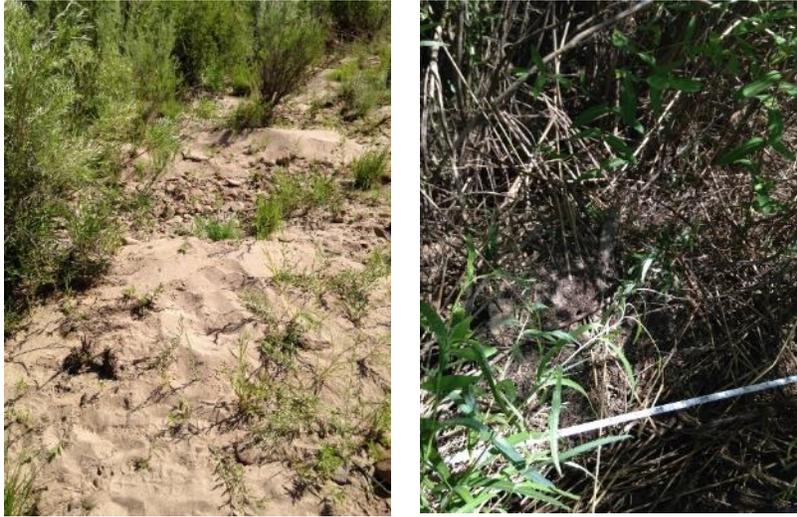
Figure 91. Areas of bare ground encountered during vegetation surveys, 2017.

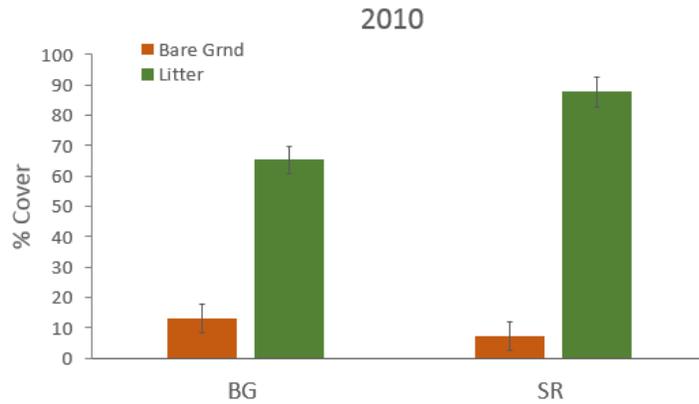
2010 Data from Big Gyp (BG) & Slick Rock (SR) sites

Figure 92. Bare ground (brown) versus vegetation litter (green) at Slickrock (SR) versus Big Gypsum (BG) sites in 2010. Note significantly higher amount of litter on sites versus bare ground in 2010.

In 2017, a lot of sediment moved up into the willow zone along the river bank with the managed release, resulting in a noticeable increase in bare ground. The percent of bare ground was over 40% at Big Gypsum in 2017, and there was significantly less leaf litter (Figures 92 and 93 below). Some seed germination was observed on new seedbeds, but was predominantly willows, not cottonwood. Again, it is believed that cottonwood seed release occurred after the managed release. She believes that the cottonwood trees usually drop their seeds in early June.

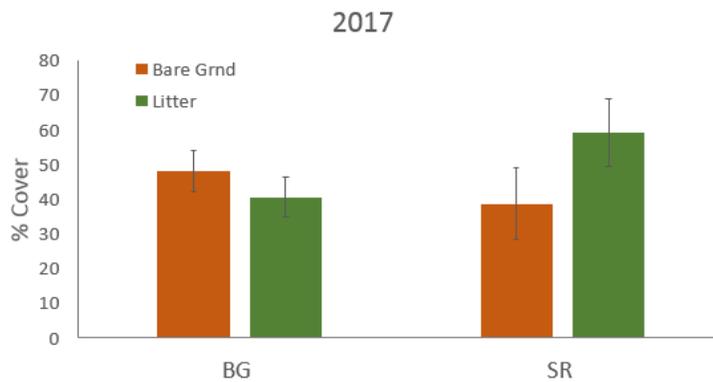
2017 Data from Big Gyp (BG) & Slick Rock (SR) sites

Figure 93. Bare ground (brown) versus vegetation litter (green) at Slickrock (SR) versus Big Gypsum (BG) sites in 2017. Note higher amounts of bare ground for both sites in 2017, while litter makes up less of the cover.

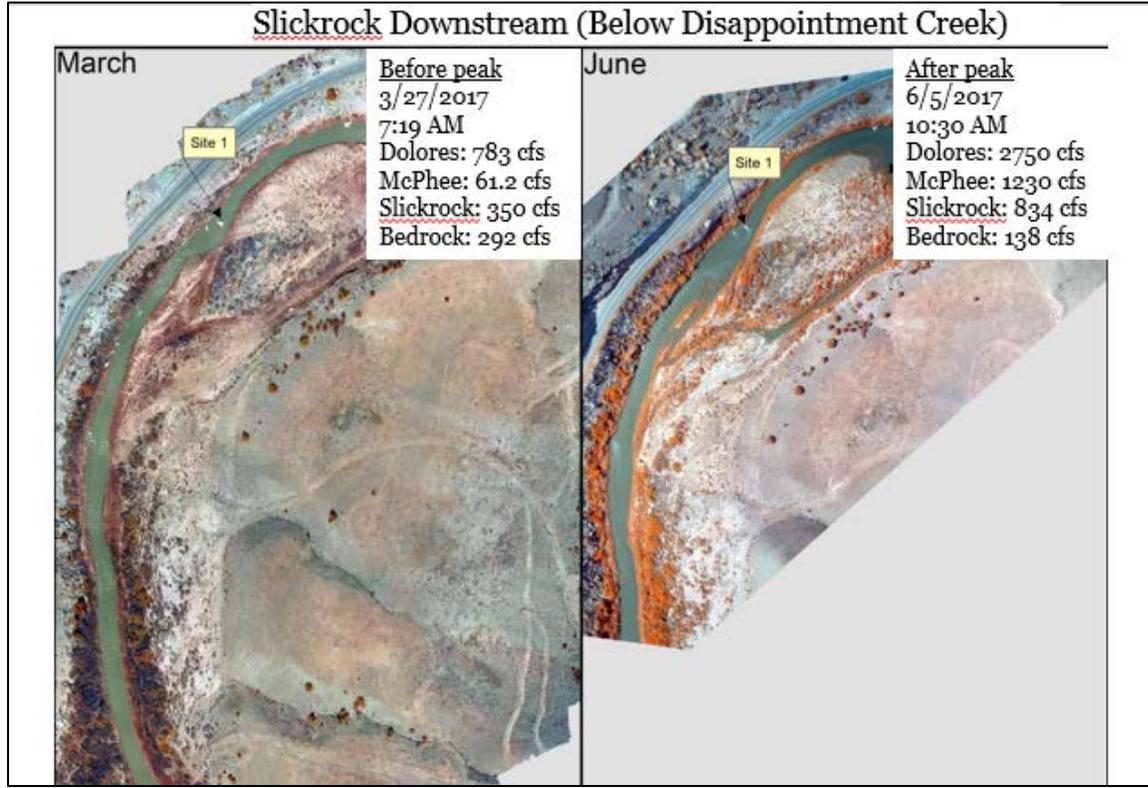
Figure 95. Drone imagery comparison March versus June 2017 at the Slickrock Downstream site. There is very little difference in planform pre- versus post-release. As noted above, most of the differences observed is because of higher water levels in June photo. Higher flow caused side-channel flow here, and floodplains stand out as a whiter color because of sand deposits.

Most of the differences observed between the two photo sets at the two sites below is because of the higher water levels in the June photos. At the Slickrock Downstream site, higher flow caused side-channel flow. The floodplains also stand out as slightly whiter at this site in these images because of sand deposits (see Figures 94 and 95 below).
